Pavement Preservation Group Study Summary of Findings 2019

Dr. Adriana Vargas

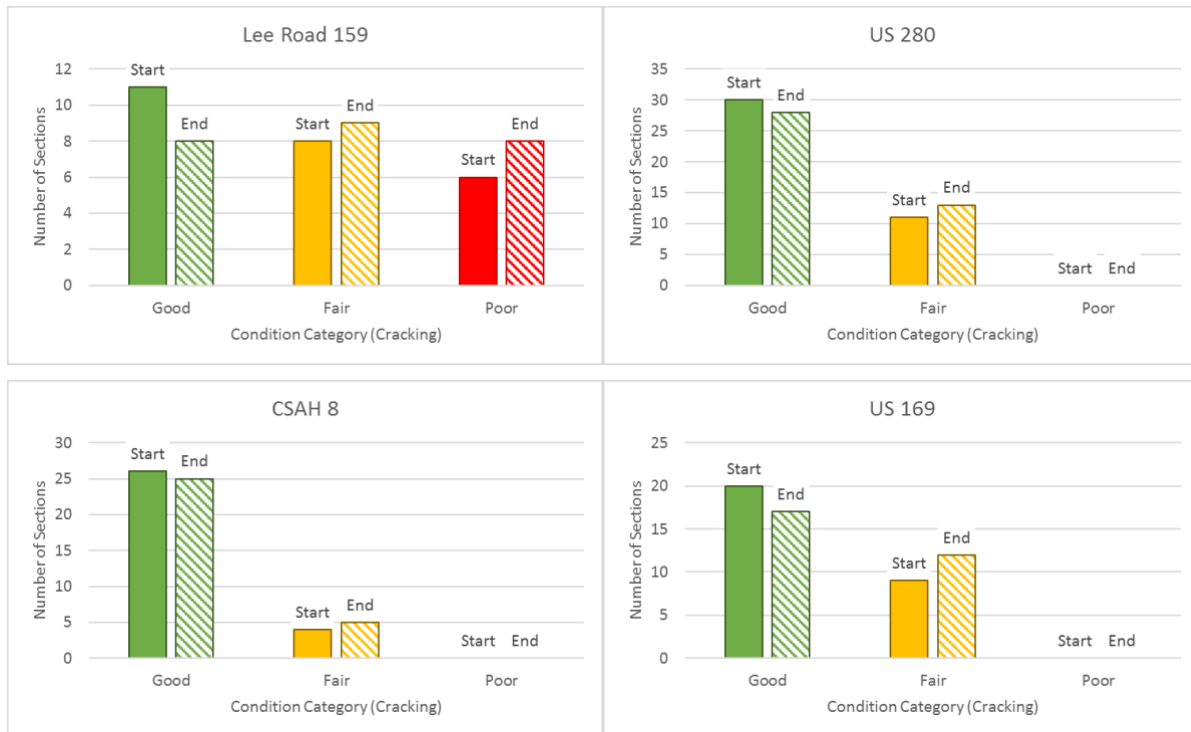
Figure 1. Number of Sections by Condition Category (Cracking)

Figure 1 shows the number of sections in each condition category at the start and end of the year for all four locations. On Lee Road 159, where test sections have been in service for a longer period (over seven years), sections are distributed more evenly among the three condition categories. Furthermore, this is the only location with sections that have reached the “poor” category, which would be expected for some of the treatments within this period. In the remaining three test locations, the majority of sections remain in the “good” condition category. However, there was a reduction in the number of sections in “good” condition in all cases, meaning some of the treatments migrated to the “fair” condition over the course of the year.

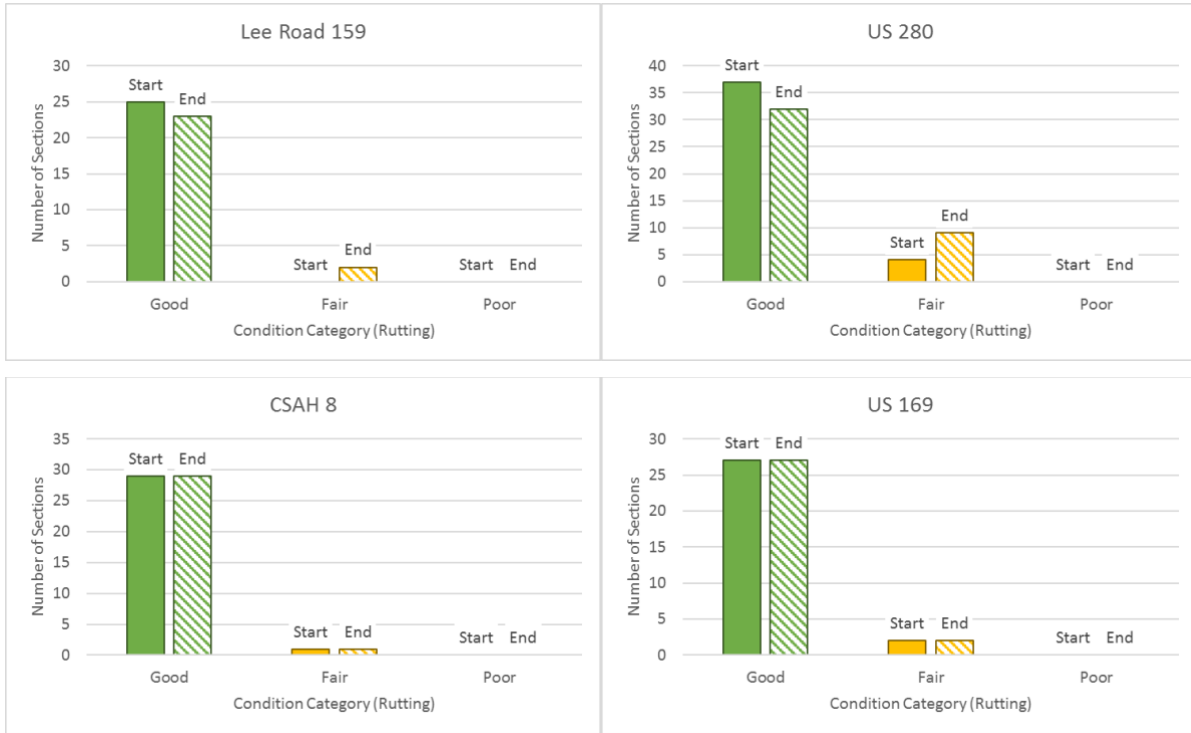
Figure 2. Number of Sections by Condition Category (Rutting)

Figure 2 shows the number of sections in each condition category at the start and end of the year for all four locations. It can be observed that only in the southern locations (Lee Road 159 and US-280), there were sections that deteriorated enough to fall under a different condition category. The northern sections (CSAH 8 and US-169) maintained their condition categories throughout the year.

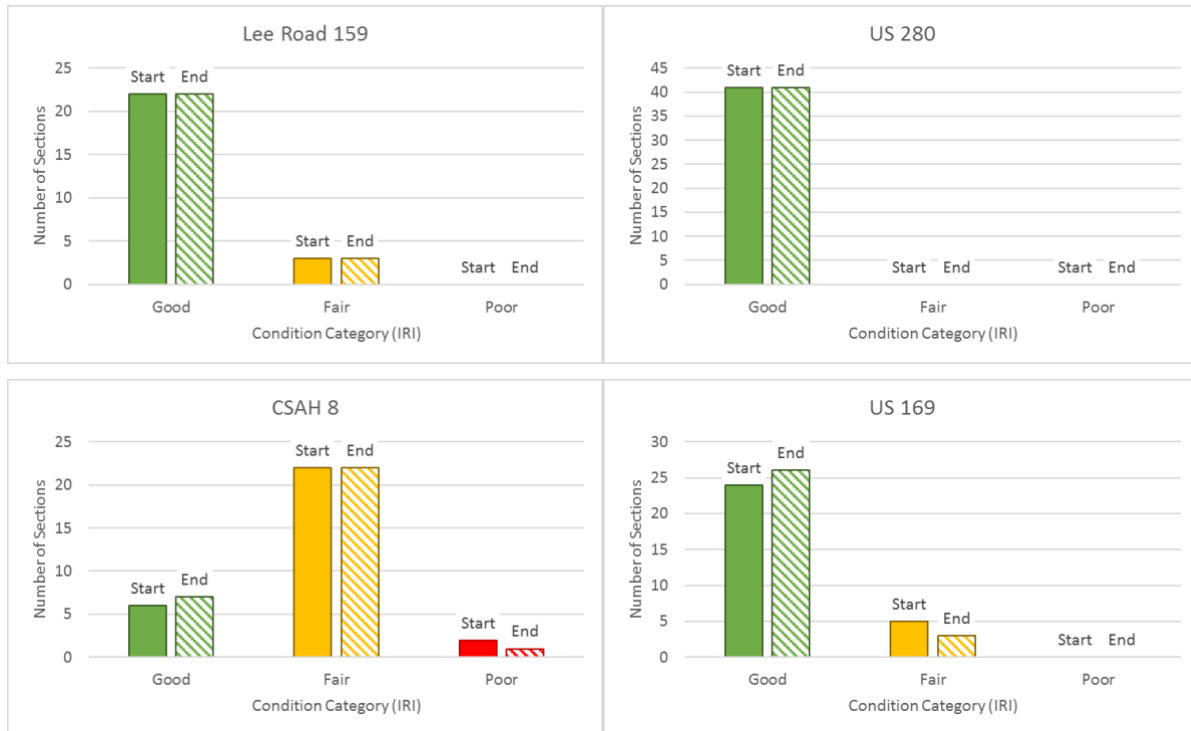
Figure 3. Number of Sections by Condition Category (IRI)

Figure 3 shows the number of sections in each condition category at the start and end of the year for all four locations. Contrary to the rutting results, there was no change in the general condition of the southern locations. Few sections in the northern sections experienced a reduction in IRI, which caused them to change condition categories. Since IRI can fluctuate, this should not be interpreted as an improvement; instead, such changes are a result of the IRI measurements being close to the threshold values that define the condition categories. Overall, roughness is higher in the northern sections even though they have been in service for a shorter amount of time.
