NCAT Report 02-12

# NCAT TEST TRACK DESIGN, CONSTRUCTION, AND PERFORMANCE

November 2002

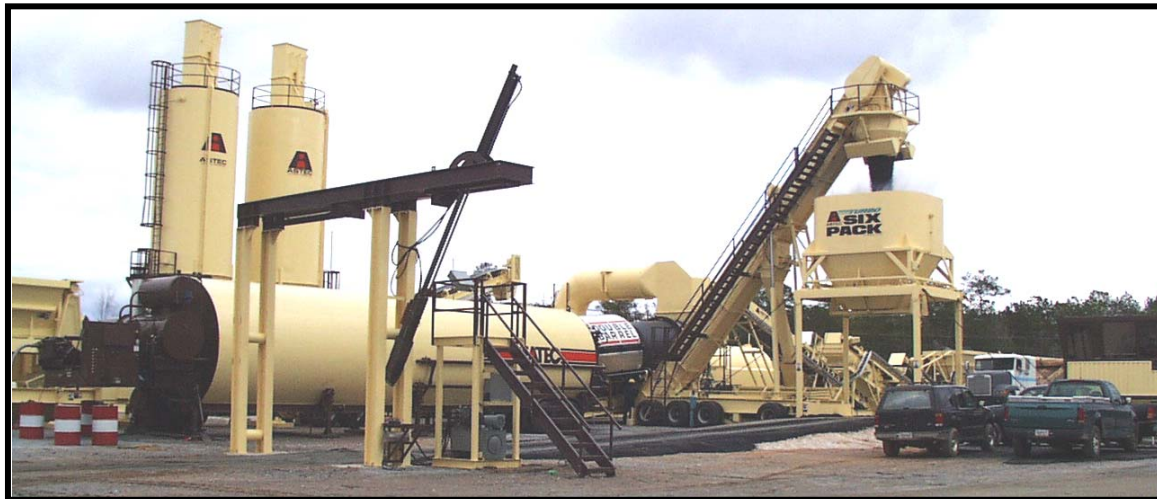
**Figure 2. Onsite Double Drum Asphalt Plant Used to Produce All Track Mix**

that were scheduled for production to minimize the effect on plant operations and resulting final mix proportions. A portable double drum plant (presented as Figure 2) was temporarily located onsite to produce mix exclusively for Track construction with minimal haul times.

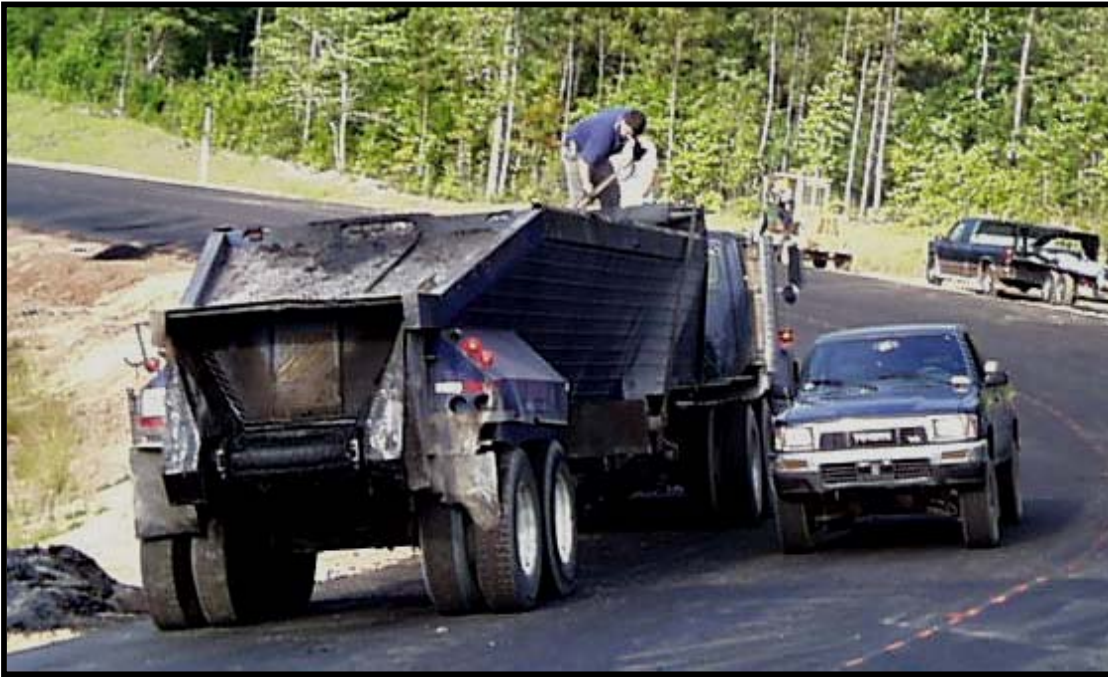
**Figure 3. Removing Shovel Sample from Truck on Roadway**

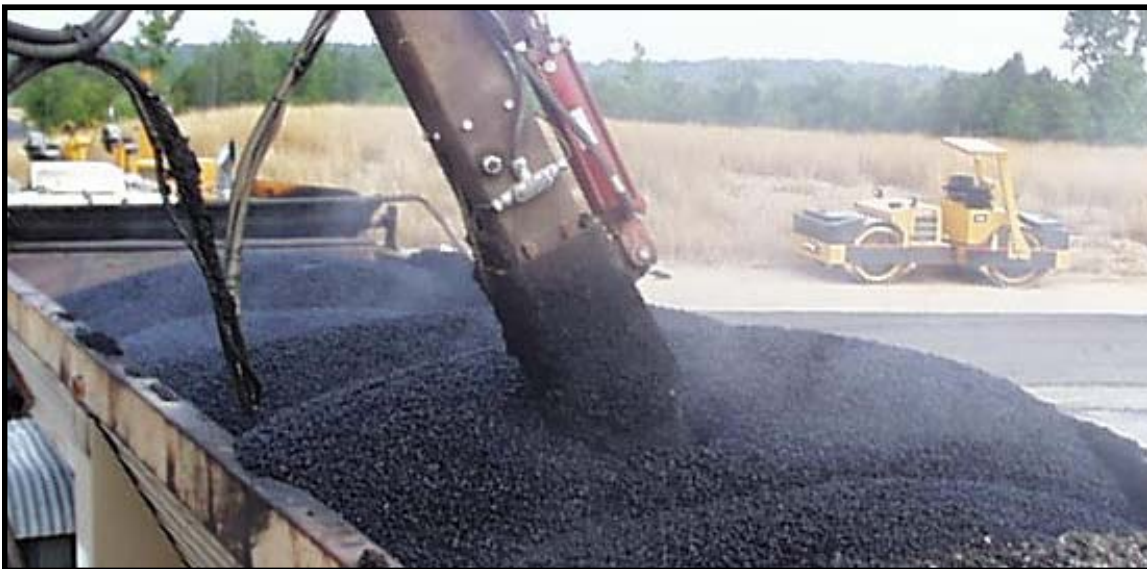
**Figure 4. Sampling Mix at Plant with Automated Robotic Sampler**

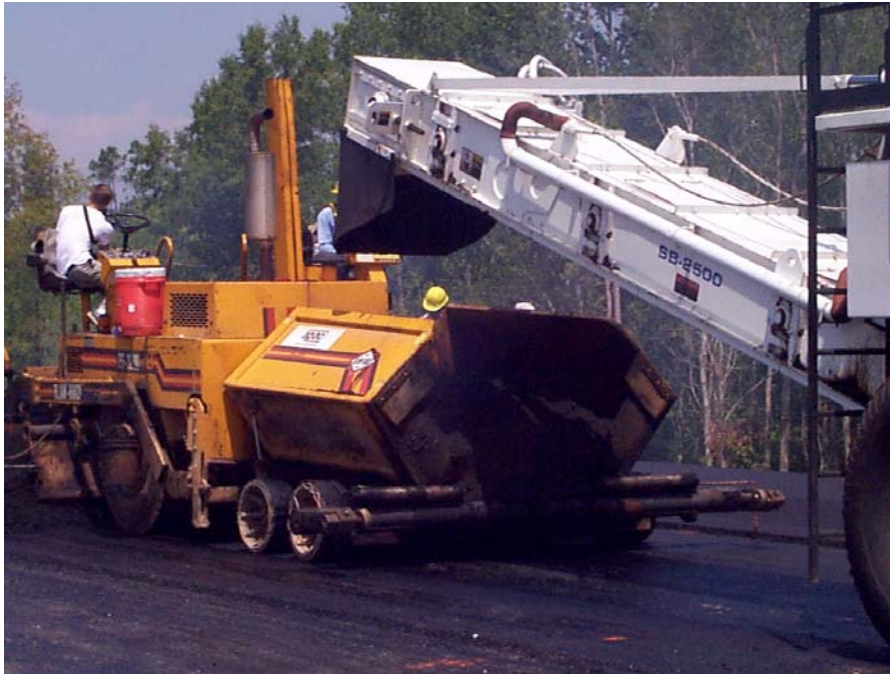
**Figure 6. Conventional Paver Placing Experimental Mix on Track**

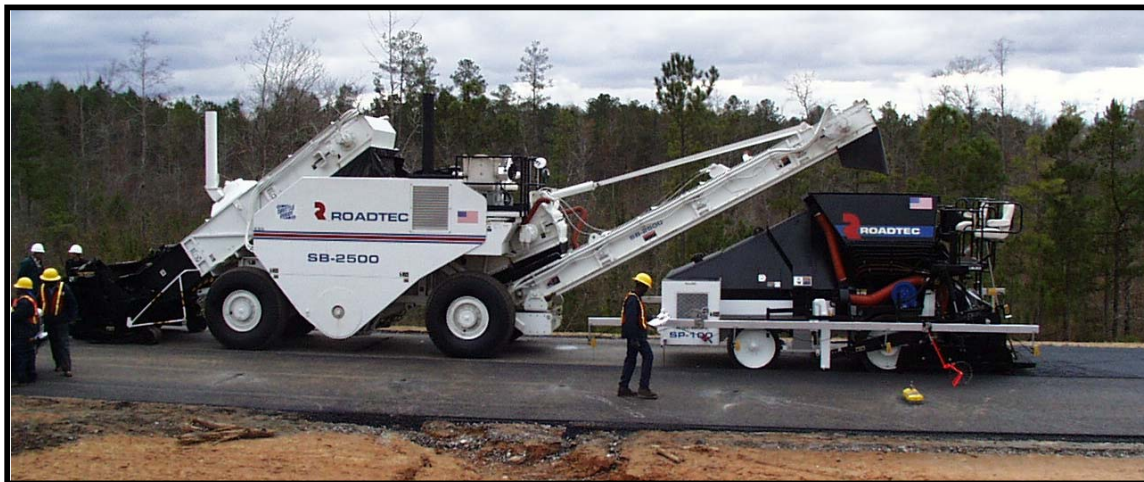
**Figure 7. Gravity Feed Paver Used to Place Experimental Mixes**

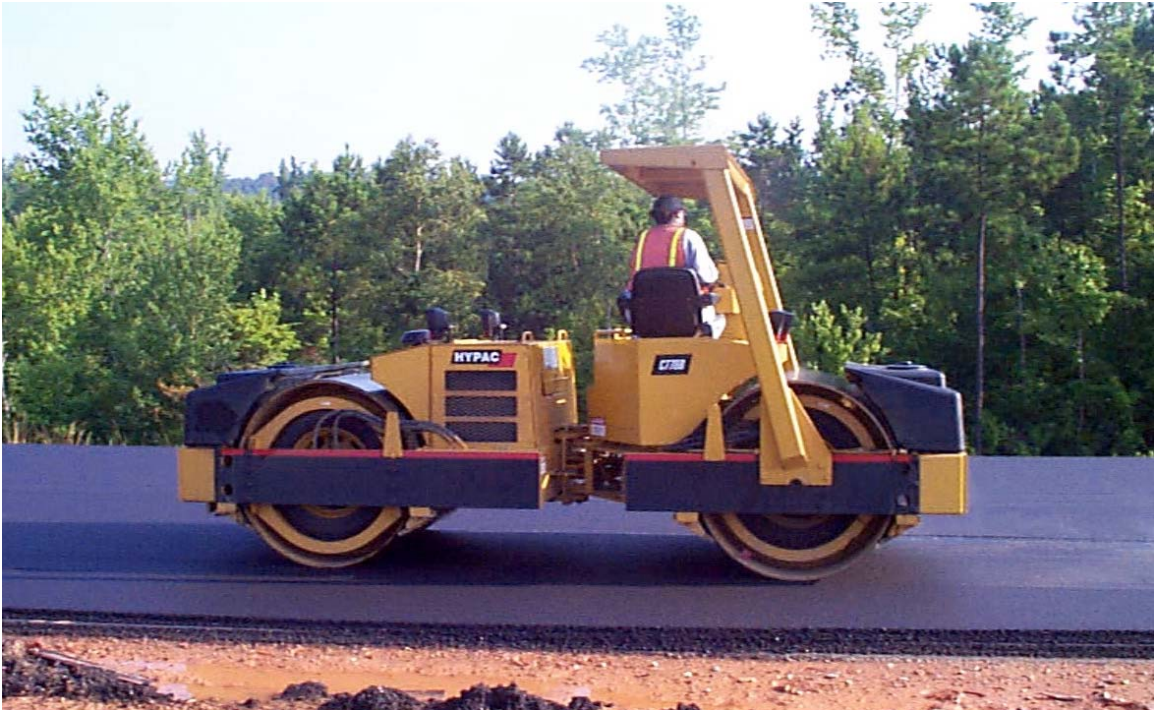
**Figure 8. Vibratory Steel Wheel Roller Compacting Track Mix**

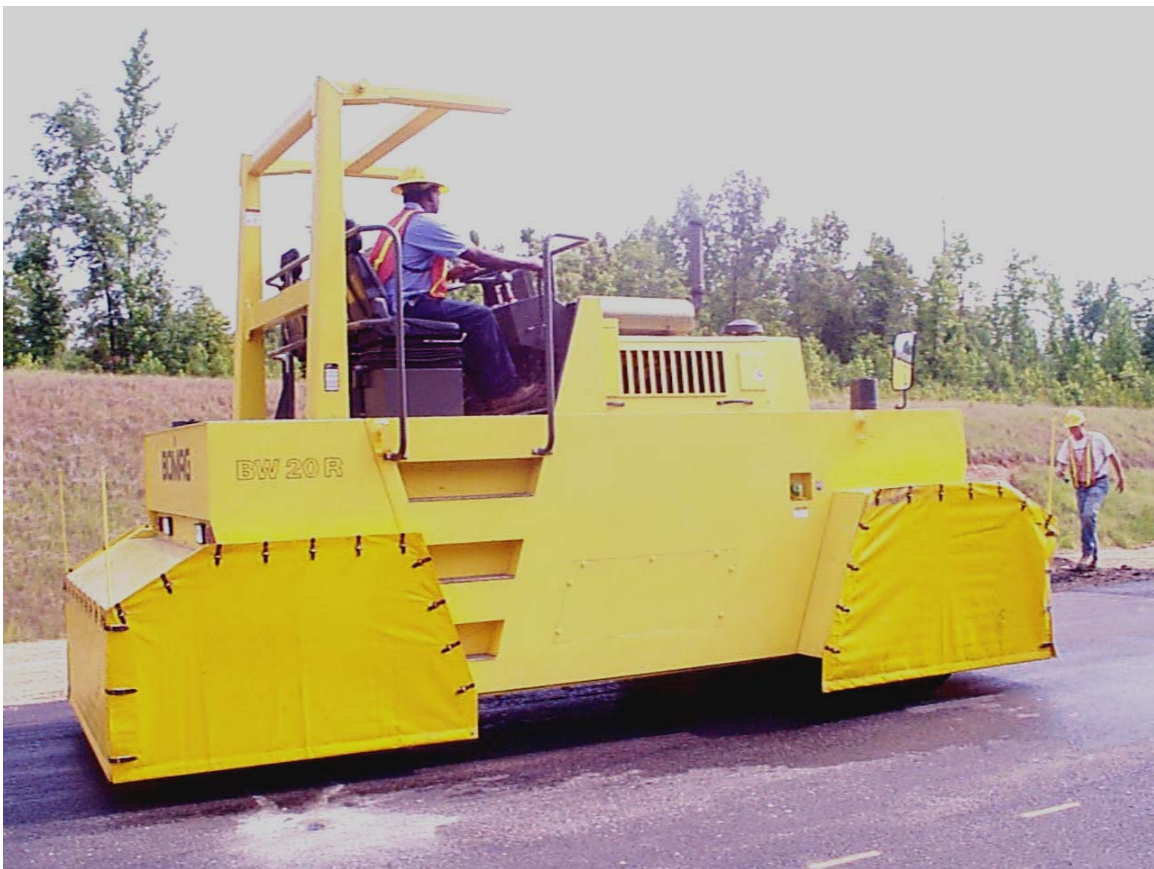
**Figure 9. Pneumatic Rubber Tired Roller Compacting Track Mix**

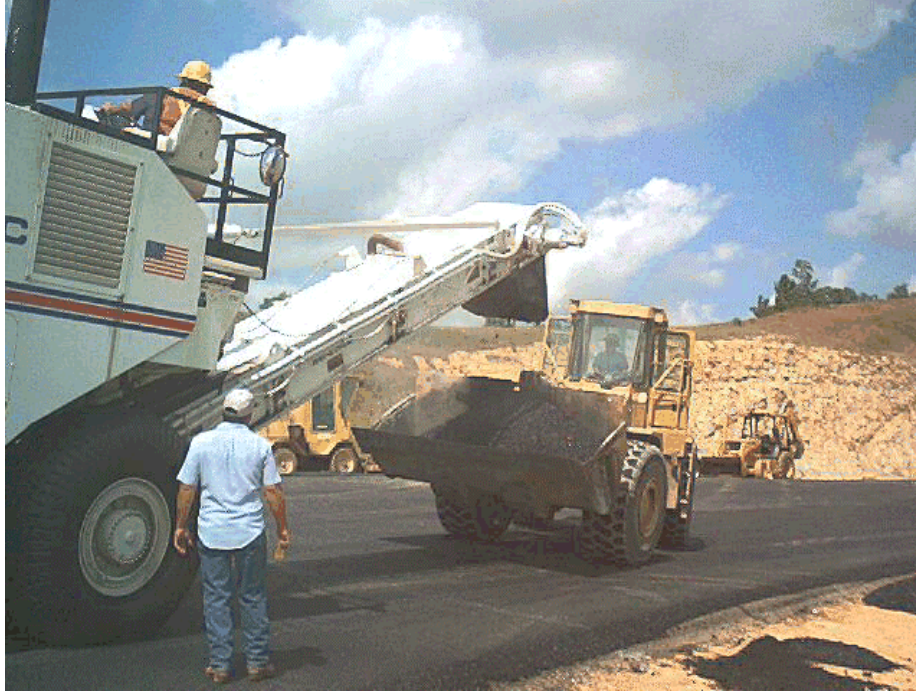
**Figure 10. Sampling Research Mix by Dumping into Front End Loader**

Concurrently, the MTD was advanced slightly and boomed over to accommodate dumping 2 to 3 tons of blended mix into a front-end loader (Figure 10). This material was utilized for the fabrication of numerous research specimens that were later used for laboratory performance testing. When filled, the front-end loader was driven back to the onsite laboratory where material was sampled and stored in buckets for later testing (Figure 11).

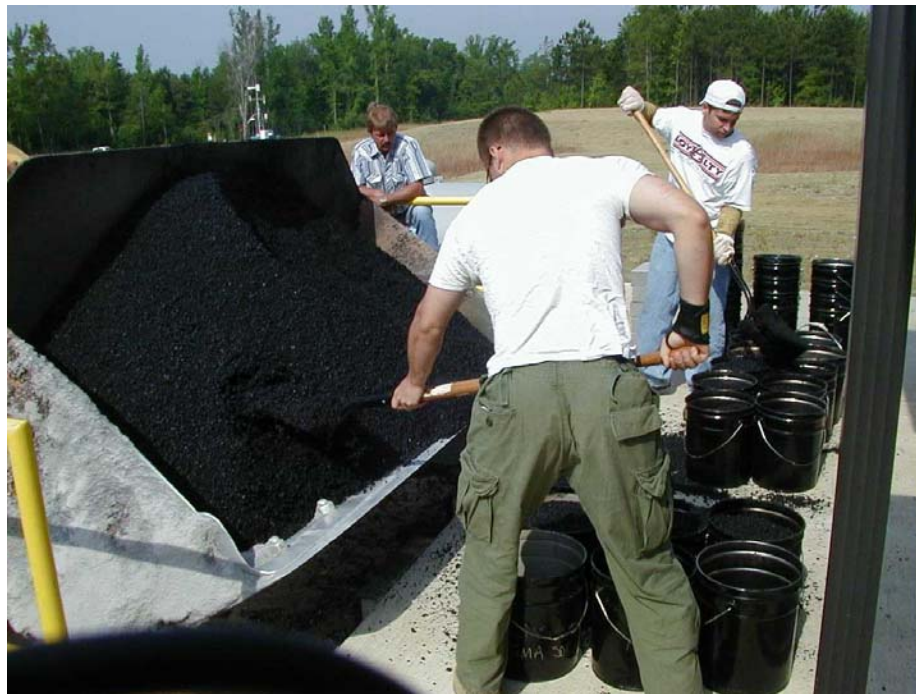
**Figure 11. Storing Research Mix in Metal Buckets**

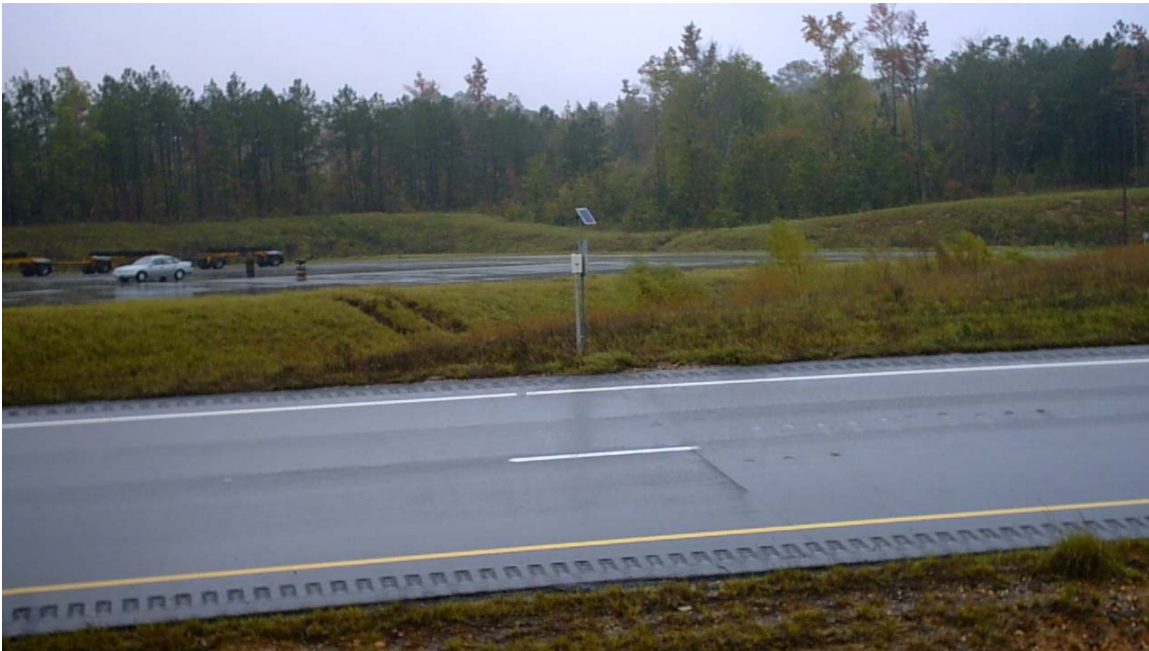
**Figure 13. Typical Datalogger Serving Two Adjacent Sections**

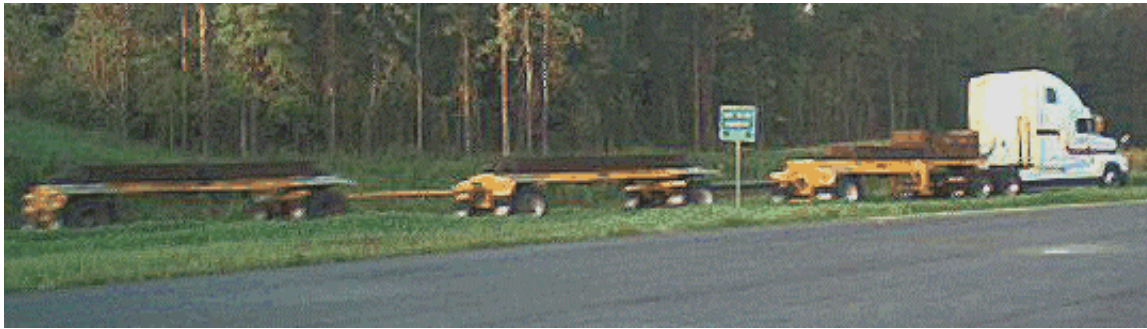
**Figure 14. Traffic Application via Triple Trailer Trains**

Four trucks haul triple trailer (tractor with 3 loaded trailers as shown in Figure 14) assemblies around the Track at 45 mph for 17 hours a day (six days a week) in order to apply 10,000,000 ESALs of traffic to the Track within two years. Although the main focus of the research is the accelerated performance of the test sections, data collected and observations made in support of the trucking operations have provided valuable information upon which future trucking operations can be refined.

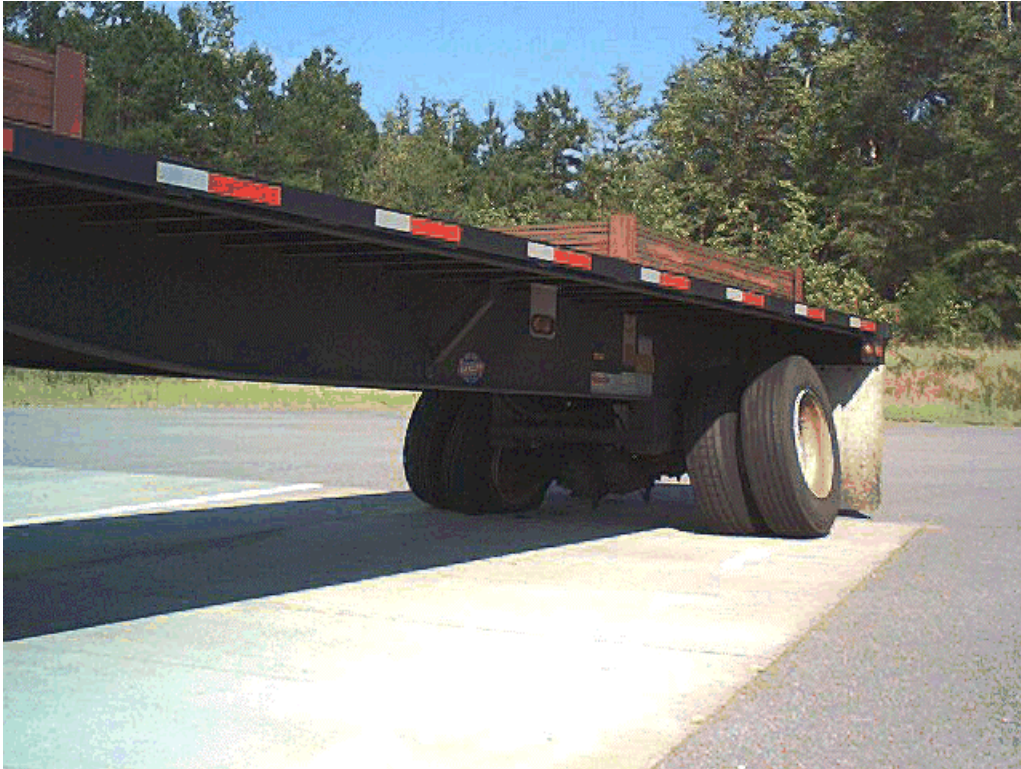
**Figure 15. Broken Rear Axle in Last Trailer of Train**

Due to the weight of the trailers, it took a truck almost a quarter of a mile to come to a complete stop. Because of the strain on the axles and the tires, several sets of tires were lost due to the wheel lug studs sheering off. Three axles failed due to the weight of the trailers and literally split in half (Figure 15). In consideration of these issues, no one was allowed on the Track while the trucks were running.

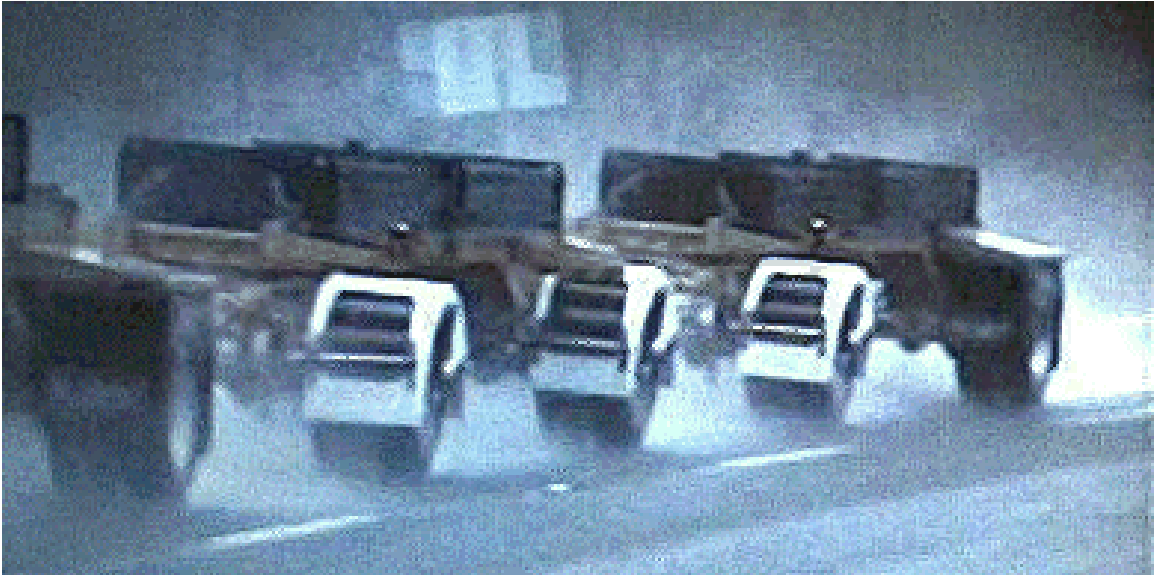
**Figure 16. Road Spray on OGFC Mix**

Several companies have participated in research associated with the trucking operation. In addition to running tire wear experiments on both virgin and recapped truck tires (in exchange for free use of the tires), experimental fenders have been added to research their potential to reduce road spray and extend tire life. Figures 16 through 18 show road spray on three different types of pavement surface: Open Graded Friction Course (Figure 16), Stone Matrix Asphalt (Figure 17), and Superpave (Figure 18). Notice that the spray is much less on the OGFC than on

the dense graded Superpave mix and the SMA mix. The spray on the SMA mix was lower than that for the open graded friction course.

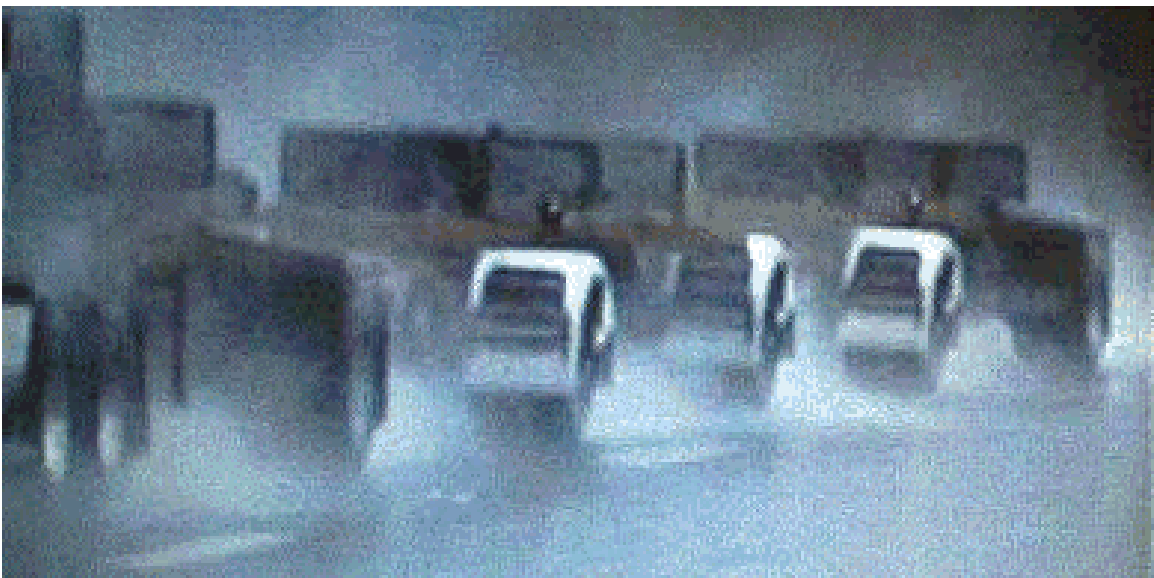
**Figure 17. Road Spray on SMA Mix**

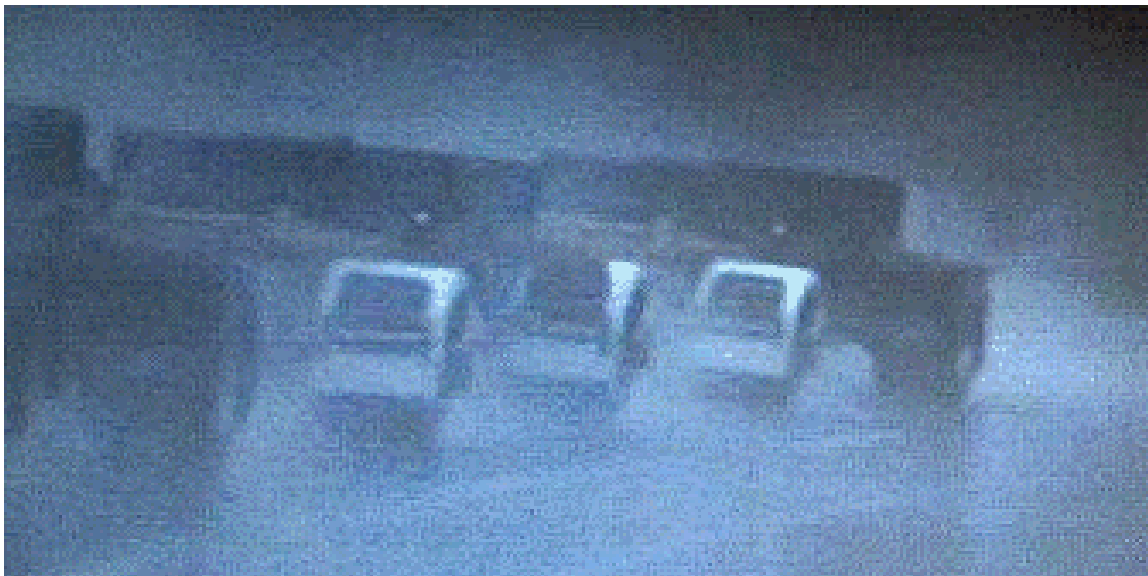
**Figure 18. Road Spray on Coarse Graded Superpave Mix**

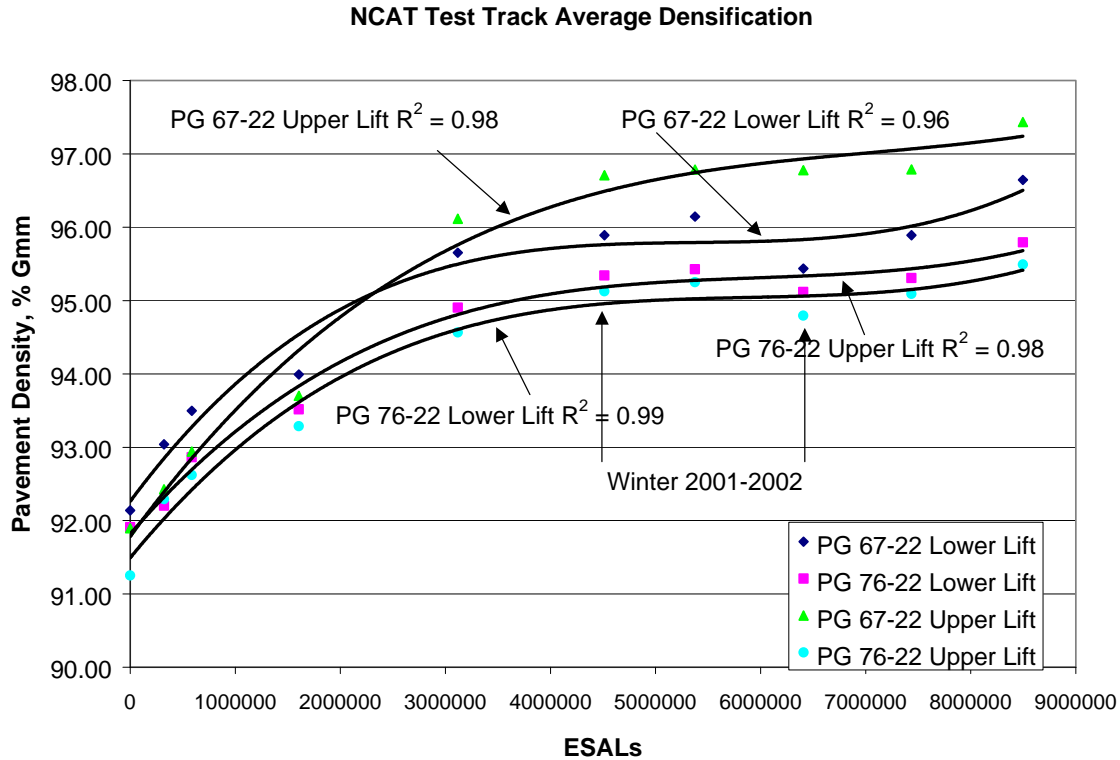
**Figure 19. Average Test Track Pavement Densification**

during the summer of 2002 (7.5 to 8.5 million ESALs) is similar to that which occurred during the summer of 2001 (3.0 to 4.5 million ESALs).

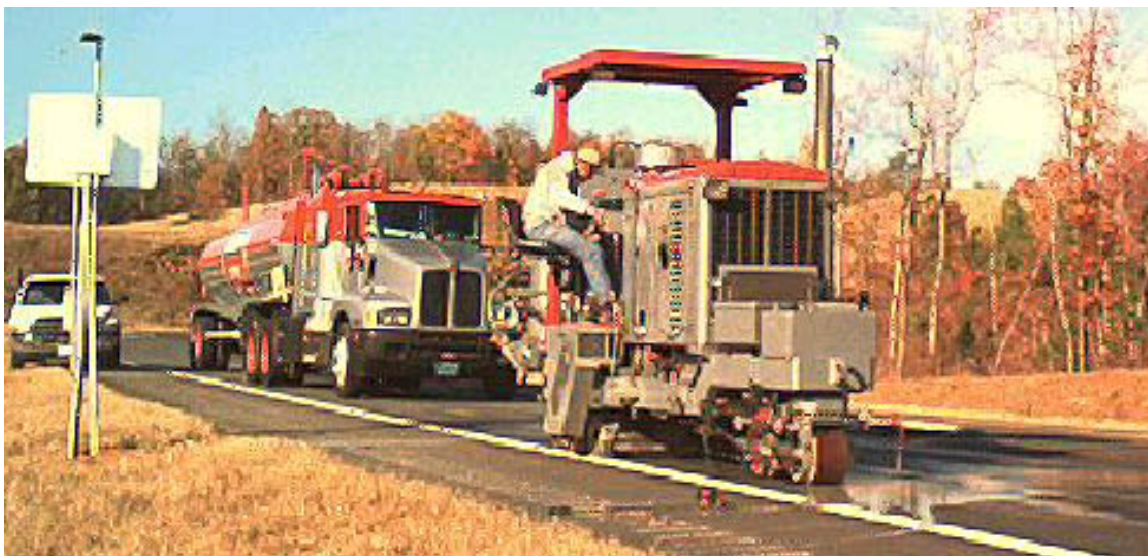
**Figure 22. Typical Diamond Grinding Operation**

Diamond grinding is similar to cold milling except diamond grinding equipment uses diamond saw blades that are gang mounted to a cutting head instead of carbide teeth. This allows more precise profiling. The cutting heads are typically 36 to 37 inches wide (914 to 940 mm), though the cutting heads on new equipment may be up to 47 inches (1194 mm) wide. The diamond saw blades are spaced to provide a corduroy texture in the ground pavement. The groove spacing varies from 50 to 60 grooves per foot (164 to 194 grooves per m). Typically, the grooves are approximately 0.06 in (1.5 mm) deep (4). Water is used to cool the diamond blades during grinding. Diamond grinding machines utilize integrated wet vacuums to remove the grinding slurry. A typical diamond grinding operation is shown in Figure 22 (NCAT Test Track November 2000).

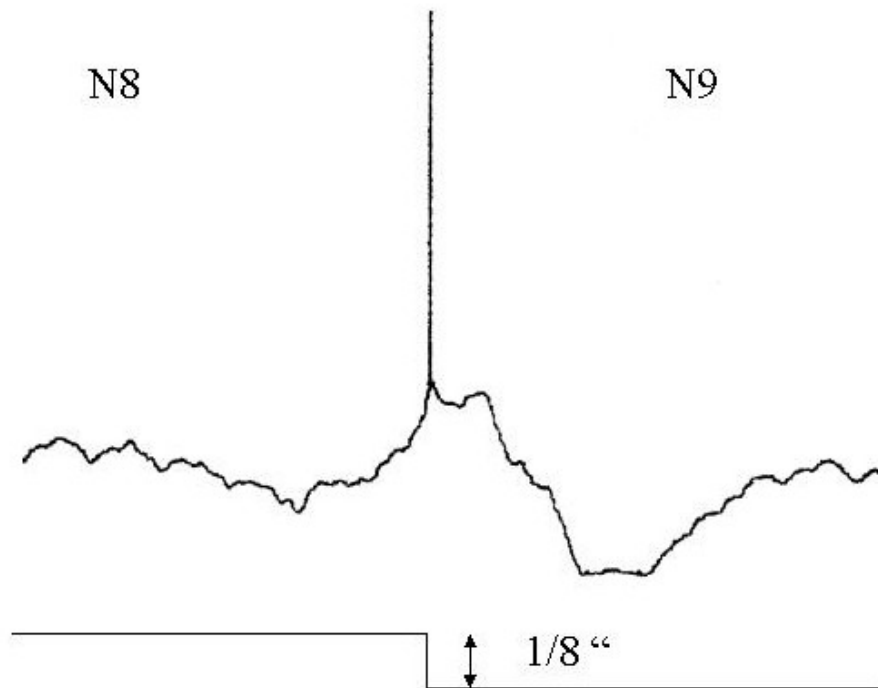
**Figure 23. Example California Profilograph Joint Profile**

Based on this evaluation, eight joints were initially identified for grinding: N8-N9, N9-N10, N11-N12, N12-N13, S1-S2, S5-S6, S6-S7 and S9-S10. Typically, grinding was performed within  $\pm 0$  to 30 feet (0 to 9.1 m) of the joint. Two sections, N9 (joint from N8) and N11 (joint leading into N12) were ground to 36 and 50 feet (11 and 15 m), respectively to accommodate dips in the as-constructed joint. Because the grinding of the initial eight joints was so successful, three additional joints were treated: N5 to N6, N7 to N8 and S3 to S4. All of the ground sections were left unsealed. A typical surface texture of a ground section is shown in Figure 24.

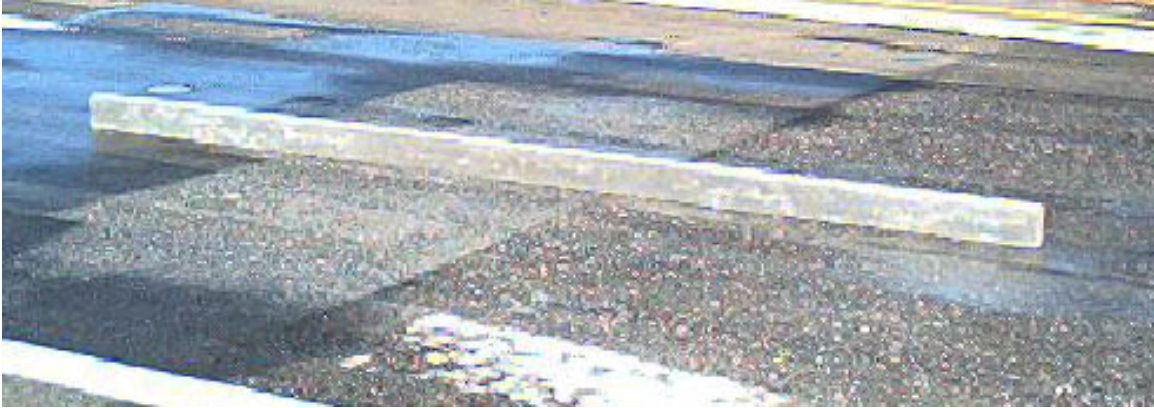
**Figure 24. Typical Ground Joint Texture**

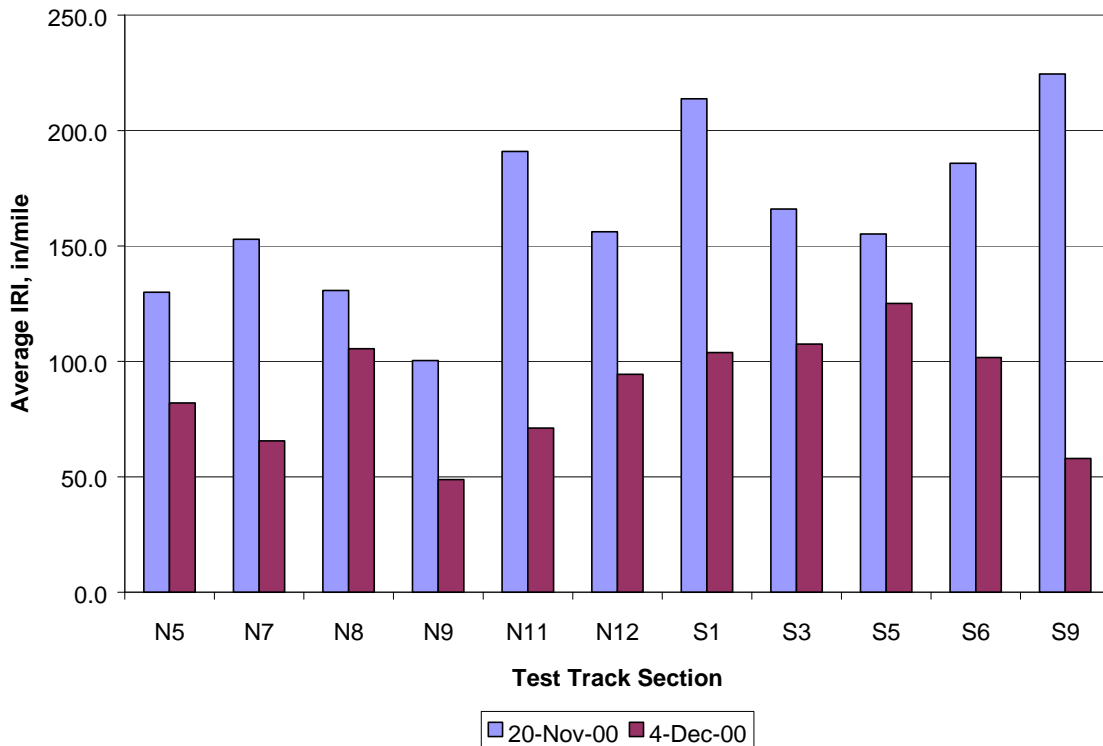
**Figure 25. Average IRI Over Joint, Before and After Diamond Grinding**

Before and after testing, measurements for IRI were also made with an ARAN van. IRI measurements were calculated using 25 ft (7.6 m) intervals. Figure 25 shows the improvement in IRI for the 25 feet (7.6 m) of pavement encompassing the joint. Diamond grinding reduced the measured IRI by 19 to 63 percent for the eleven sections treated. The average improvement was 45 percent. Overall, diamond grinding the eleven joints improved the average IRI for the test track (1.7 miles) from 68.7 inches per mile (1.08 m/km) to 65.9 inches per mile (1.04 m/km).

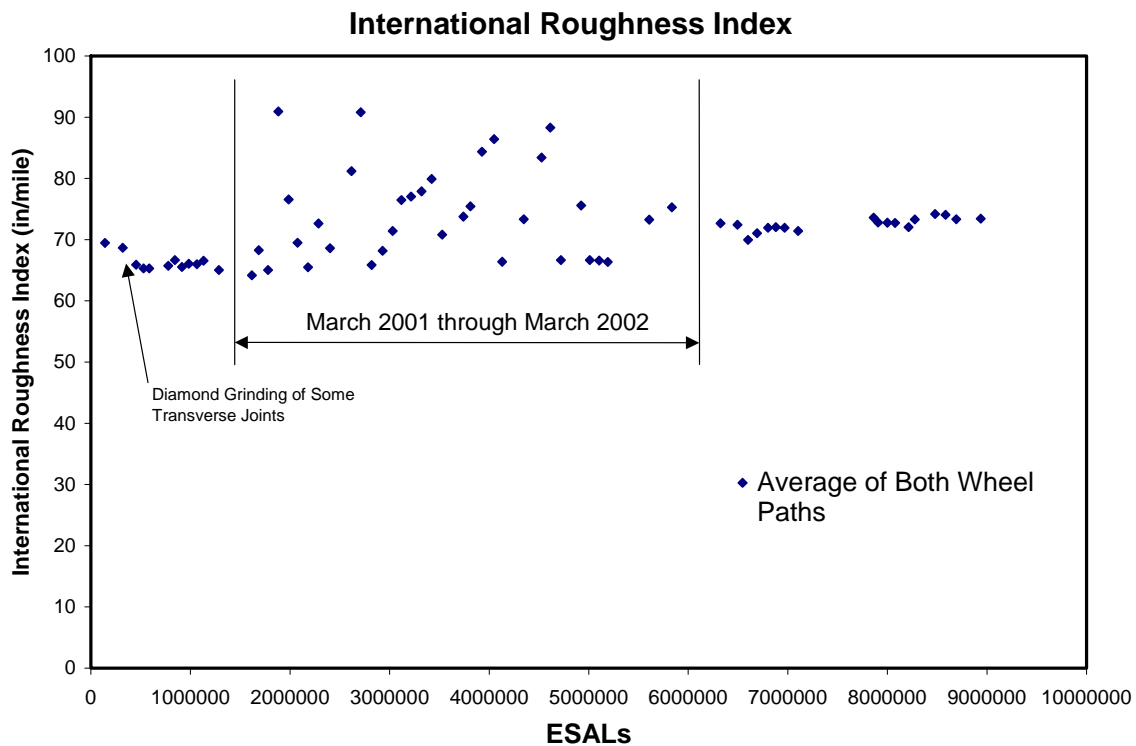
Figure 26. Average Track Roughness Over Time

Based on the data presented, all of the test sections (including those not shown) exhibited relatively low IRI values. Therefore, the average IRI values shown in Figure 26, which includes all of the transverse joints, illustrate that the rideability of the Test Track was good. Most test sections had low IRI values indicating that there is no significant difference in the smoothness that can be obtained with different mix types.

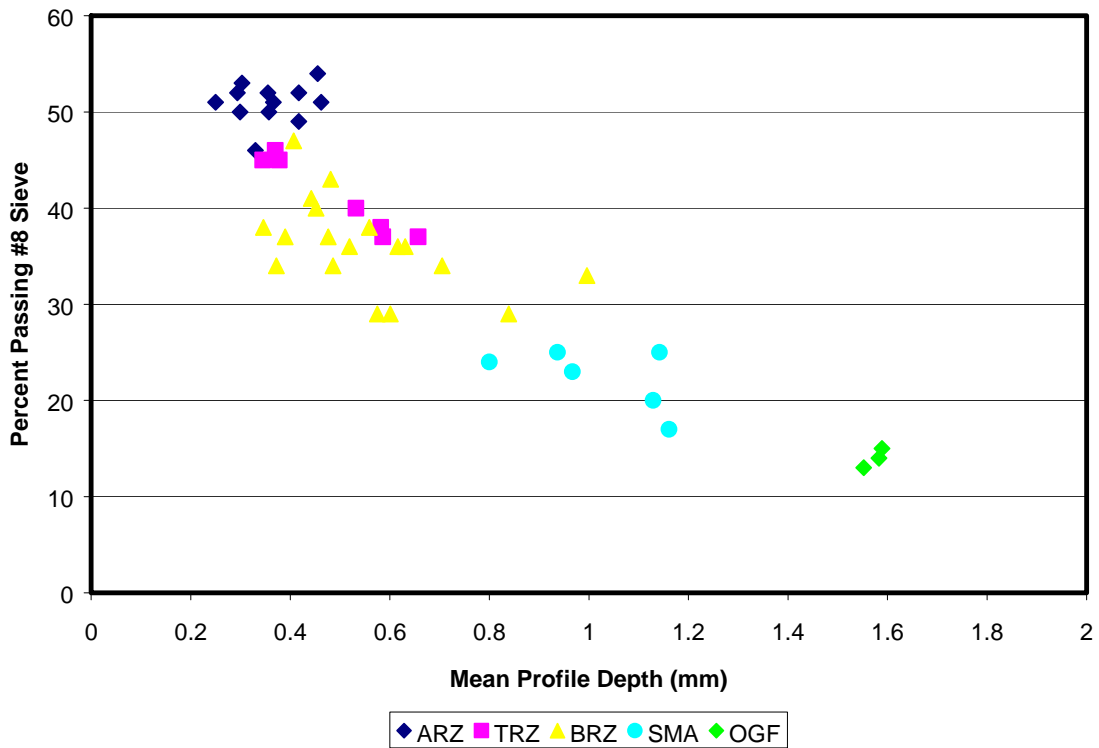
Figure 31. Mean Profile Depth Versus Percent Passing the 2.36 mm Sieve after 4.81 million ESALs

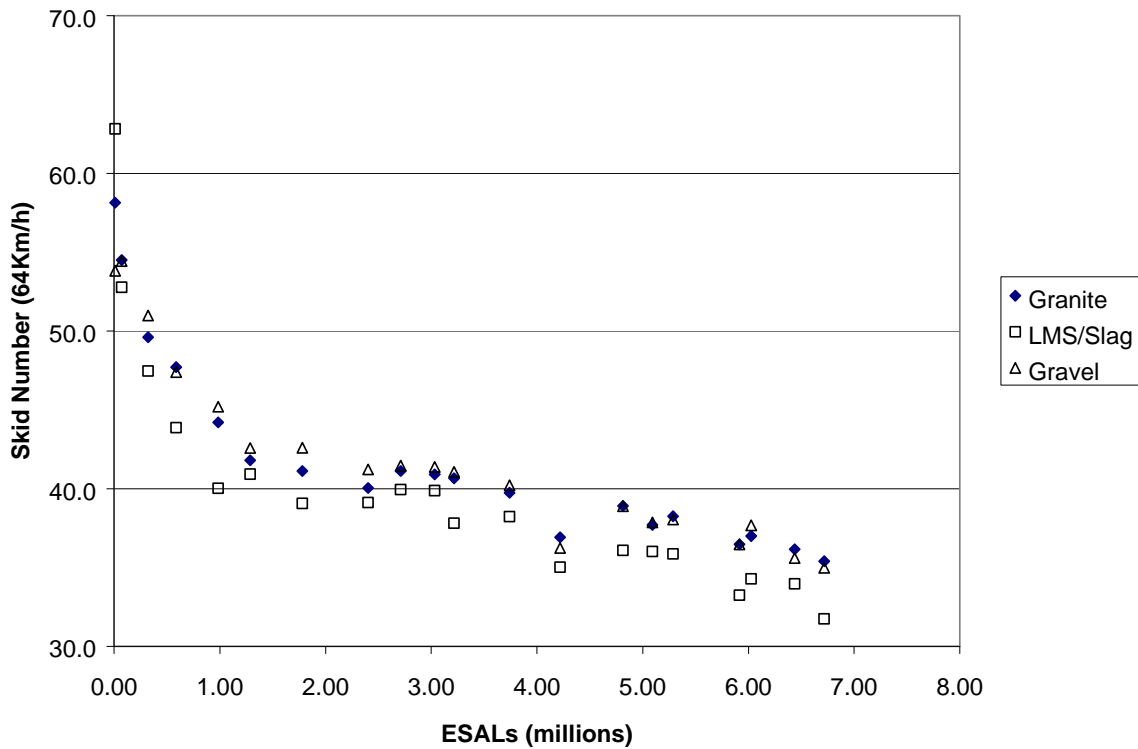
**Figure 33. Ribbed Tire Skid Number versus ESALs as a Function of Aggregate Type**

Certain aggregate types are prone to polishing under traffic. This action may lead to a reduction in skid resistance with time. Seven major aggregate types were represented at the test track: granite, limestone/slag blend, gravel, Limestone, limestone/RAP blend, quartzite and sandstone. Only three of these aggregate types (granite, gravel and limestone/slag) had numerous replicates. Figure 33 shows the average ribbed tire skid numbers as a function of ESALs for the granite, gravel and limestone/slag sections. Several agencies add slag to limestone blends to improve polish resistance. Figure 33 indicates that the limestone/slag sections had the highest skid number at the time of construction. However, after 4.8 million ESALs, the limestone/slag mixes had lower friction than the granite and gravel mixes.

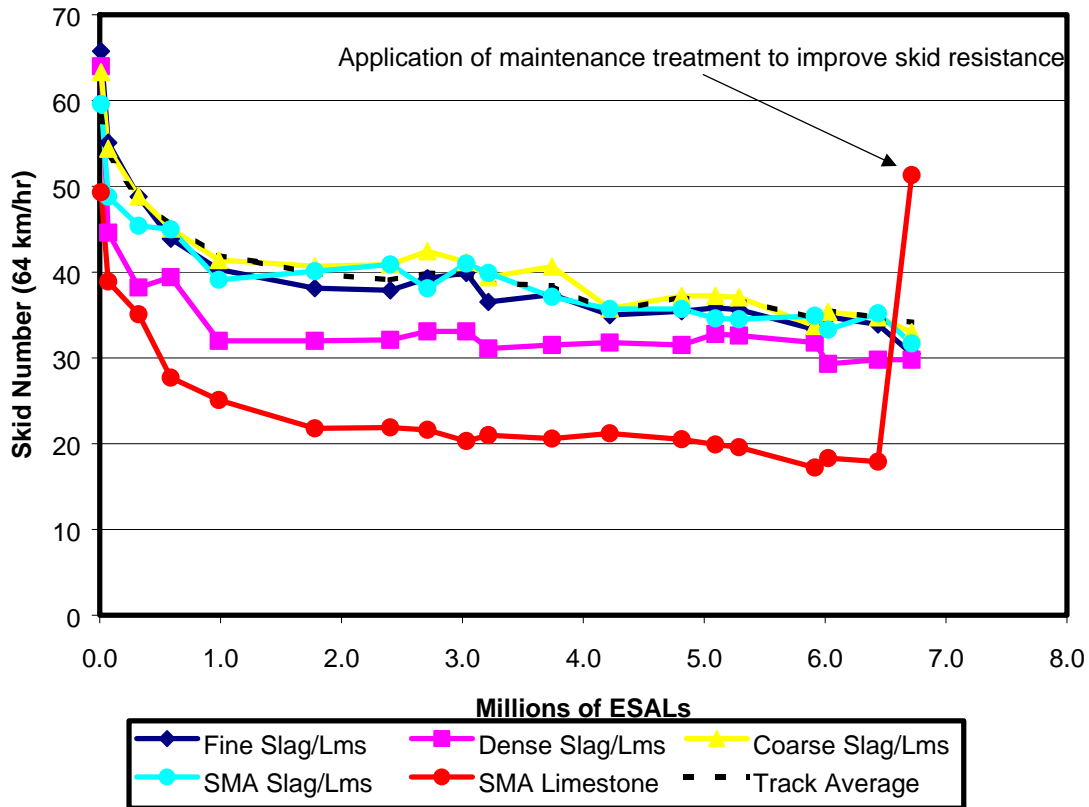
**Figure 34. Comparison of Ribbed Tire Skid Number versus ESALs for Track Section Containing Limestone**

The use of hard (low LA Abrasion) cubical aggregates is emphasized for SMA mix designs. Alabama Department of Transportation placed an experimental SMA section on the NCAT test track consisting solely of a native limestone source. The limestone coarse aggregate blend had an LA Abrasion value of 20. The section was placed to evaluate whether the increased macrotexture common to SMA mixes would overcome the tendency of the limestone to polish under traffic. Unfortunately, as shown in Figure 34, the limestone SMA polished causing a reduction in skid resistance. The rate of reduction in skid resistance increased after the application of 5 million ESALs. Once it was clear that the macrotexture of the SMA would not overcome the polish susceptibility of this particular aggregate, a thin maintenance treatment was applied to the section to improve skid resistance. This result does not indicate that limestone cannot be used in SMA, however, one should ensure that the limestone or any other aggregate is resistant to polishing.

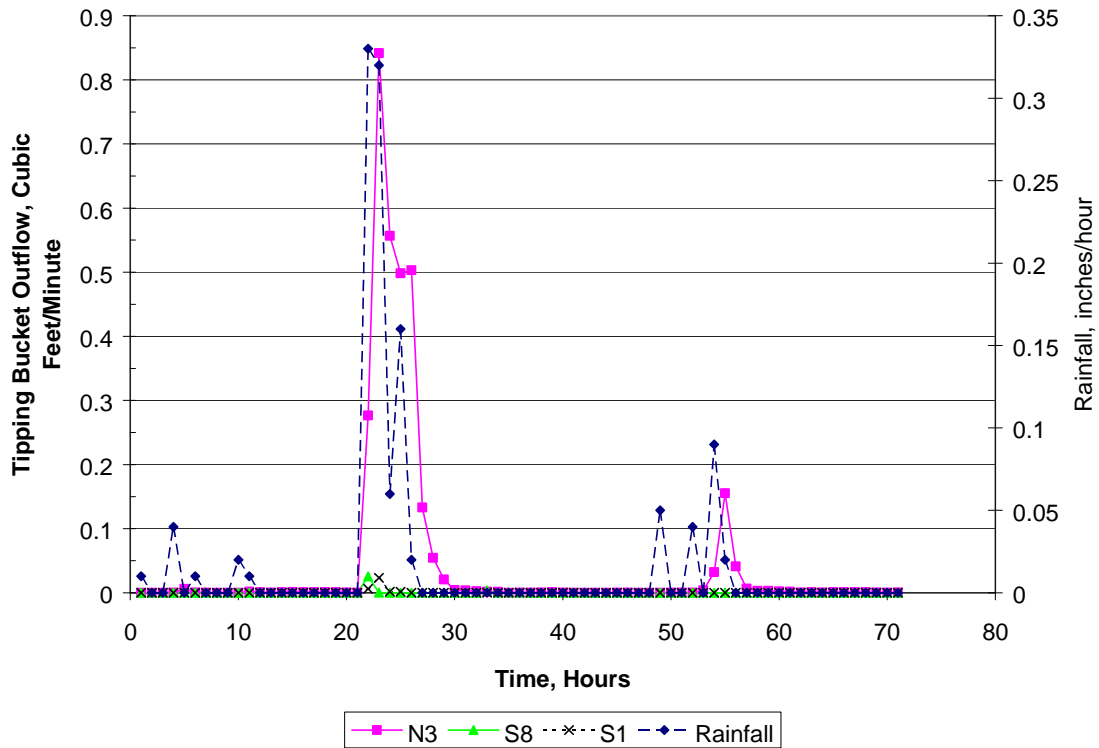
Figure 37. Example Edge Drain Outflows

Tipping buckets connected to CR10X Data loggers were installed on three outlets adjacent to sections N3, S8 and S1. Both sections N3 and S8 were in fill sections while section S1 was a cut section. Water flow was regularly observed from the outlet pipes during rain events. An example of the outflow is shown in Figure 37. From Figure 37, it is evident that the outlet pipe adjacent to section N3 had the greatest outflow with a peak flow of 0.85 cubic feet per minute. Peak flows for section S1 and S8 were approximately 0.025 cubic feet per minute. This difference is typical of the data and somewhat surprising considering section N3 and its adjacent sections were fine graded ARZ mixes. One possible explanation is that more water entered the joint between the driving lane and shoulder due to the relatively impermeable surface. However, the moisture is more likely to be coming into the drainage system from the embankment outside the shoulder. This is consistent with the short time delay between the peak rainfall and peak outflow from section N3.

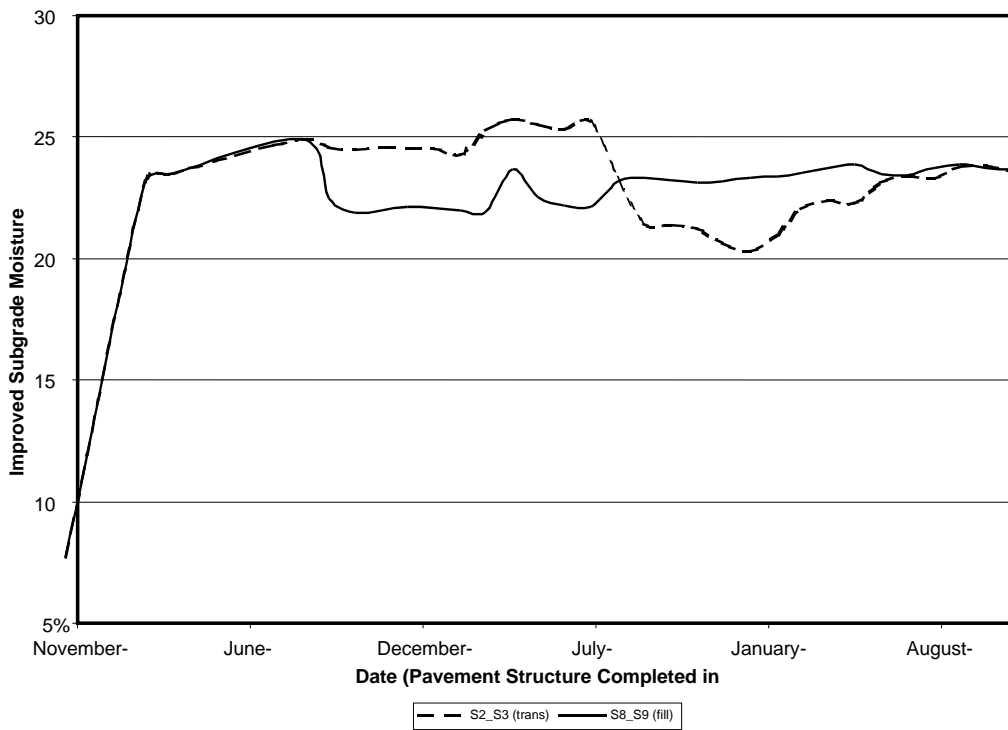
Figure 40. Subgrade Moisture for Sections S2-S3 and S8-S9

The moisture in the improved subgrade was controlled to be near optimum (approximately 10%) during compaction. Moisture sensors were installed in November 1999 and were monitored manually until November 2000. At that time the instrumentation was connected to equipment that provided continuous readout. A sample of the data is illustrated in Figures 38-41. For illustration purposes, two sections were selected at random on each of the four sides of the track. Three sections were taken in fill areas, three in cut areas, and two in transition areas. The first manual reading was obtained in November 1999 and found to be approximately 10%. The next manual reading was taken in March 2000 and at that time all of the readings at the 8 locations shown were approximately 22-25%. Each sensor was located in between two different sections therefore the location of each sensor was identified by two sections. After the continuous readings began in November 2000, it appears that the moisture continued to stay at approximately 22-25%.

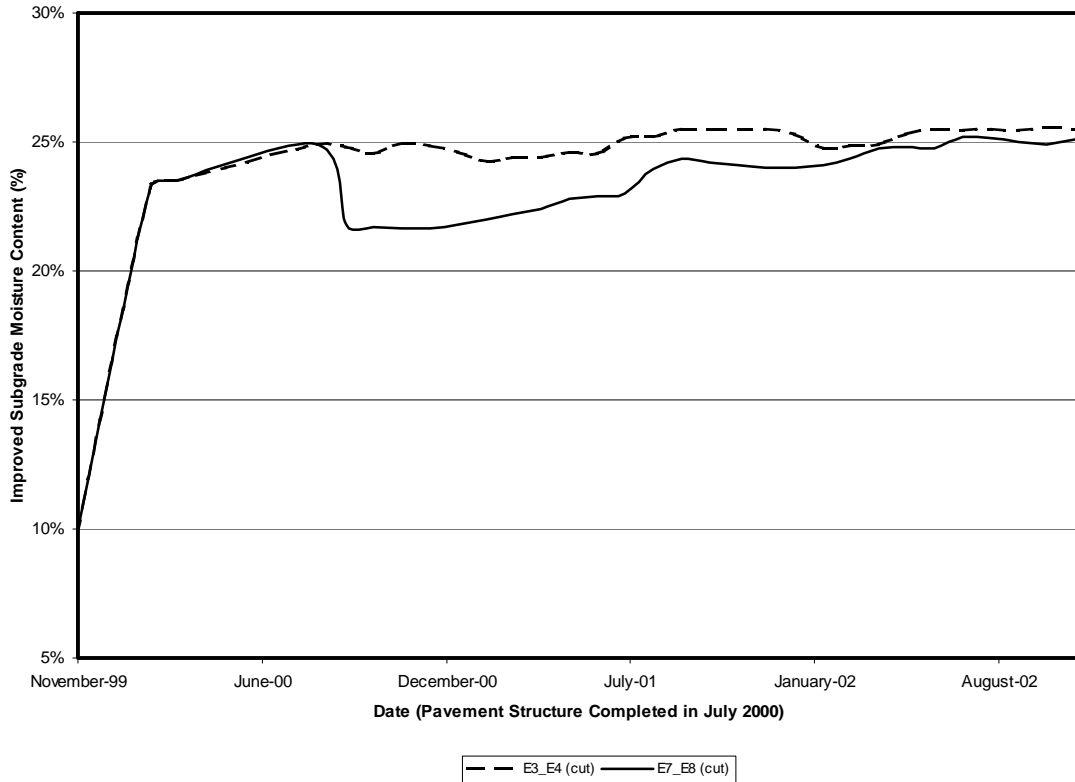
**Figure 41. Subgrade Moisture for Sections E3-E4 and E7-E8**

This consistent moisture content is interesting since much of the track was built on fill areas and much was built in cut areas. There appears to be no difference between cut and fill areas. Also the amount of rainfall varied significantly during various parts of the year. Regardless of the changes in climate or whether or not it was in a fill or cut area, the moisture content stayed approximately constant after it initially reached the 22-25% range. Of course the sampling location was well below the surface so any variation in moisture would be minimized. In pavement design it is typically assumed that the subgrade will become saturated with time underneath the watertight pavement surface. The data collected at the track tends to support this assumption.
