NCAT Report 02-12

# NCAT TEST TRACK DESIGN, CONSTRUCTION, AND PERFORMANCE

November 2002

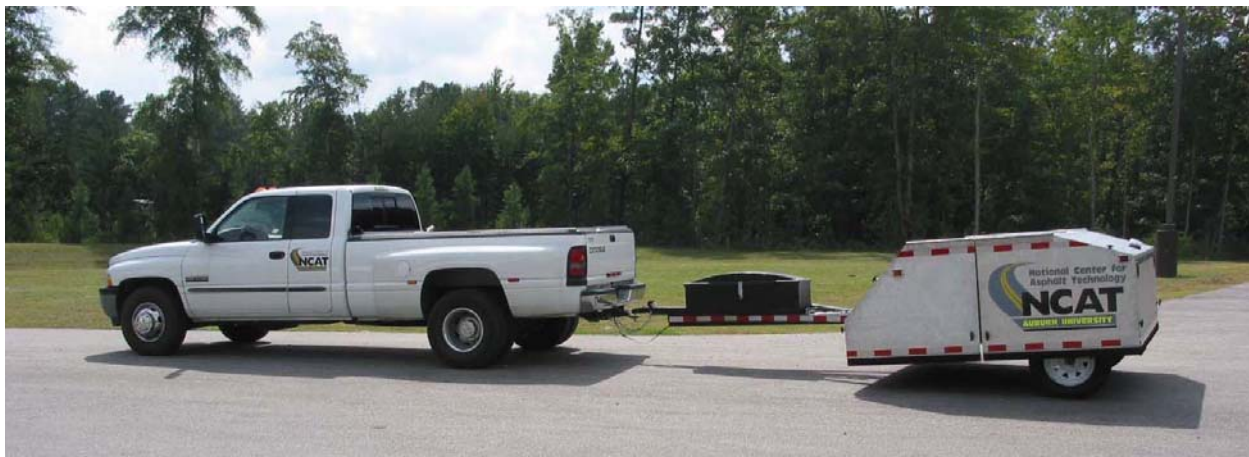
**Figure 56. NCAT CPX Trailer**

The National Center for Asphalt Technology designed and built a CPX trailer for the Arizona Department of Transportation (ADOT) during the Fall of 2001. It was delivered to ADOT in late January 2002 and is being used by ADOT to evaluate a number of pavement surfaces in Arizona. In October 2002 the second generation CPX trailer was delivered to NCAT and is now being used to conduct studies at the Track. Figure 56 shows a picture of that new trailer.
