**NCAT Report 18-04**

**PHASE VI (2015-2017)  
NCAT TEST TRACK FINDINGS**

**JULY 2019**

**National Center for  
Asphalt Technology**  
**NCAT**  
at AUBURN UNIVERSITY

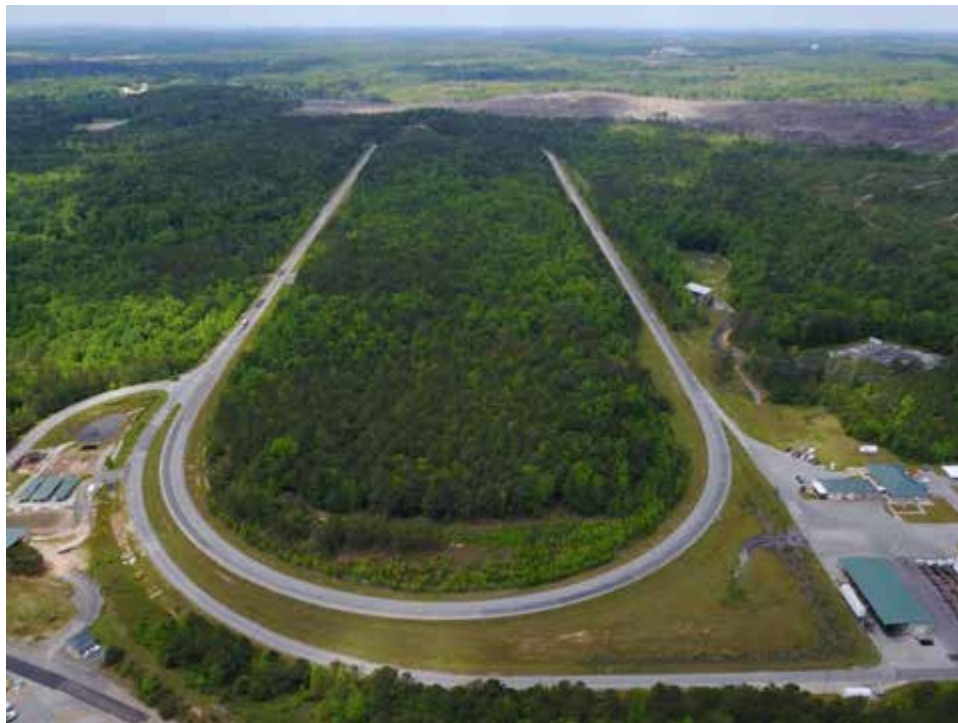
**Figure 1 Aerial Photograph of the NCAT Test Track**

The National Center for Asphalt Technology (NCAT) Test Track is a pavement proving ground that was originally constructed from 1998-2000. This 1.7-mile oval track is a unique accelerated pavement testing facility that utilizes full-scale pavement construction of test sections and highway-speed, heavy trafficking to provide analysis of asphalt pavement responses and performance in just a few years. This provides the opportunity to realistically evaluate cutting-edge technologies and assist sponsors in implementation of materials and design methods that advance safe, durable, and sustainable asphalt pavements.

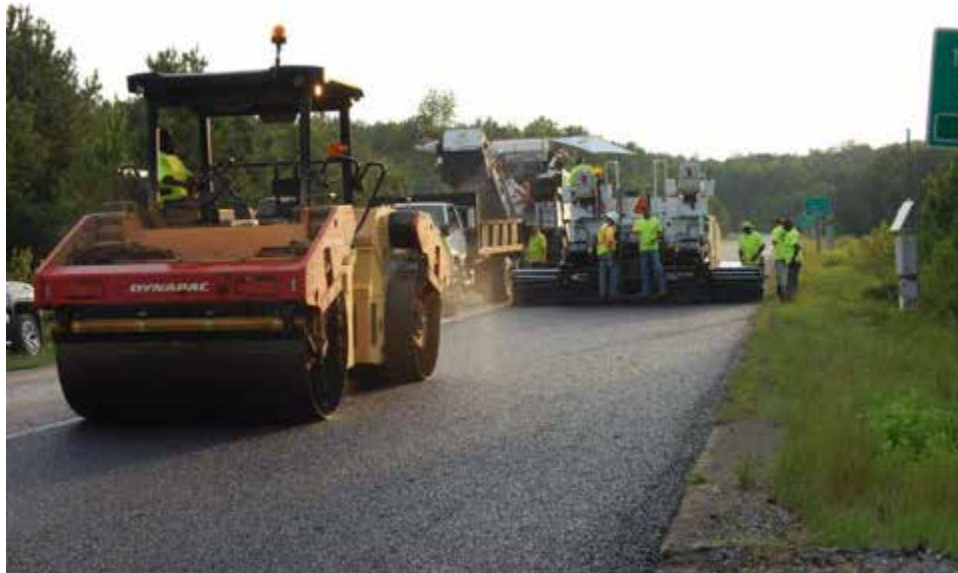
**Figure 2 Paving a Test Section for the 2015-2017 Research Cycle**

Mix produced for placement on the test sections followed the same production sequence described above. Mix production continued until a sufficient quantity of material was available for placement. The contractor was responsible for hauling mixes to the track, and the paving equipment and crew were staged at the track.

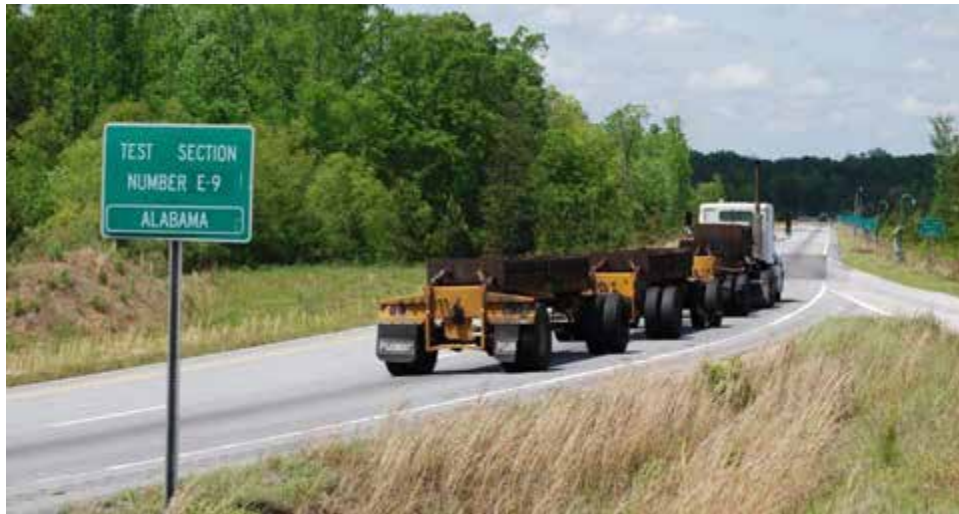
**Figure 3 Heavily Loaded Triple-Trailer used for Accelerated Loading on the Test Track**

Trafficking for the 2015 Test Track was applied in the same manner as with previous cycles. Two shifts of professional drivers operated four trucks pulling triple flatbed trailers (Figure 3) and one truck pulling a triple box trailer from 5 a.m. until approximately 10:40 p.m. Tuesday through Saturday. Trafficking began on October 8, 2015 and ended November 28, 2017. The total traffic applied to the test sections during this cycle was 10,009,457 ESALs.

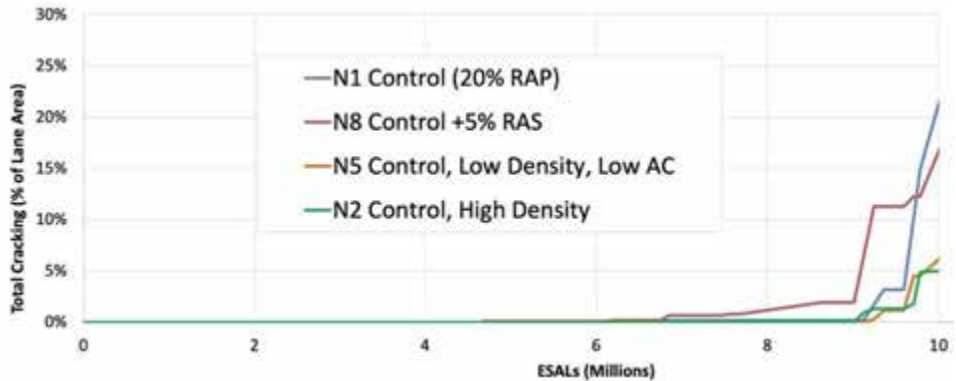
**Figure 2 Plot of Cracking in the Cracking Group Test Sections Through the 2015-2017 Cycle**

Although some cracking has begun to appear in several of the Cracking Group test sections, only N8 has progressed sufficiently for it to be meaningful. Therefore, all of these test sections will be left in place during the next cycle of the Test Track to allow for better separation of field cracking performance. This will help establish better relationships with the laboratory cracking test results.

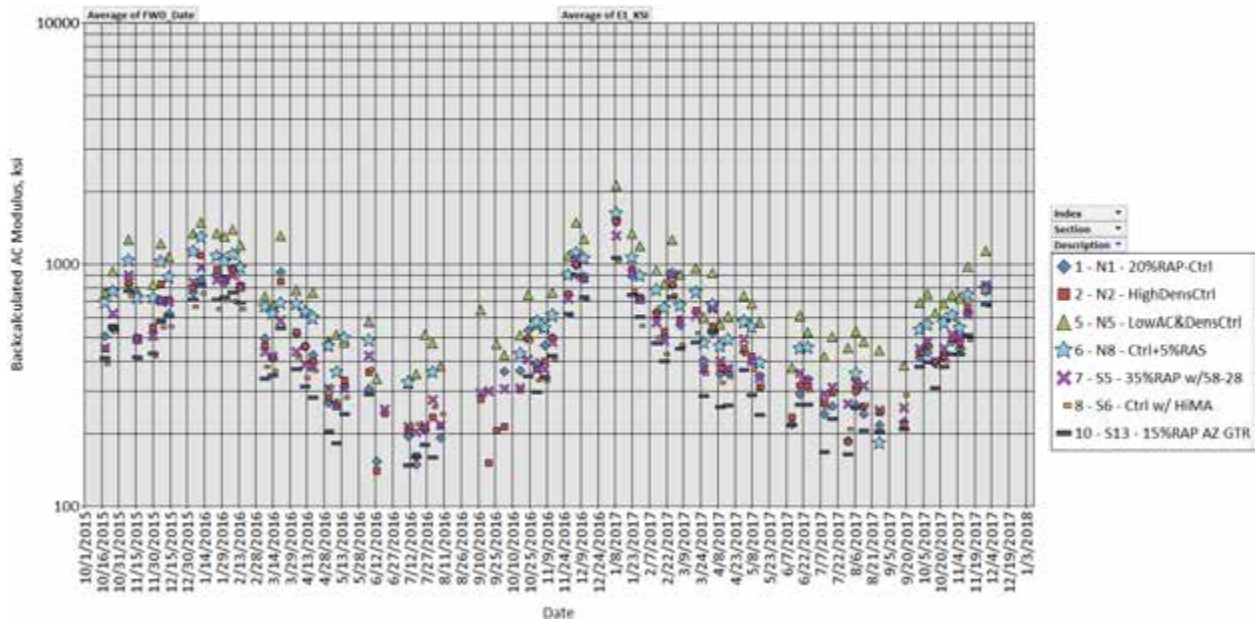
**Figure 14 Asphalt Modulus Versus Date**

Backcalculated asphalt concrete moduli are plotted for each section versus date in Figure 14. These backcalculated asphalt moduli are, in essence, composite moduli for the three asphalt layers in each section. Similar to the measured pressure responses, the seasonal trends are clearly evident, and it should be noted that these values are section-wide averages based on the date of testing. Due to the temperature variation covering approximately an order of magnitude, it is difficult to discern any long-term potential aging or effects of pavement damage on this data set.

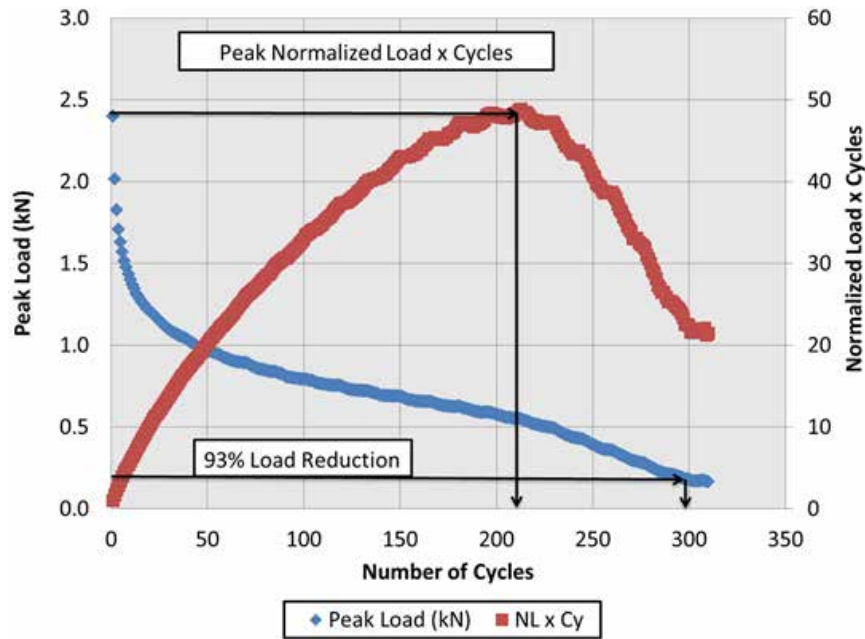
**Figure 21 Determination of Failure Point for NCAT-OT vs. TX-OT**

NCAT developed a modified version of the Overlay Test (11) that differs from the Tex-248-F method in three ways: 1) cycle frequency, 2) maximum opening displacement, and 3) the failure definition. The NCAT-OT method is performed with a one second cycle rather than ten seconds. The NCAT-OT method uses a 0.381 mm maximum displacement rather than 0.635 mm required in Tex-248-F. The smaller maximum displacement better simulates reflection cracking strain levels in flexible pavements. The NCAT-OT method uses the peak of the “normalized load x cycle” curve to identify failure as this approach closely matched when cracks propagated completely through the specimen as evident in video analysis. A comparison between the failure definitions of the two methods is shown in Figure 21. The cycle that corresponds to the maximum product of the load and the cycle is reported as the  $N_f$  for the test. The NCAT-OT method was shown to have lower variability than Tex-248-F (11).

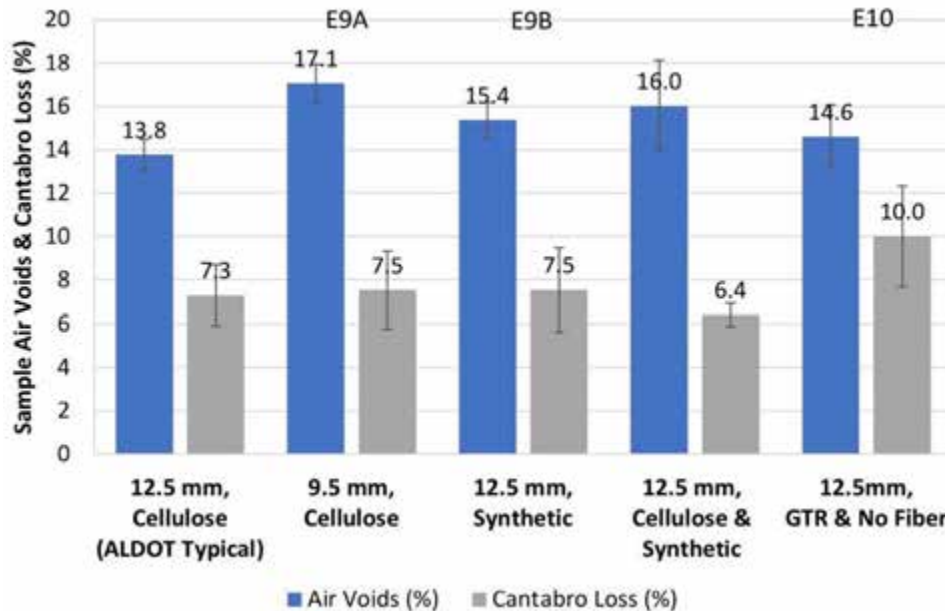
**Figure 2 Comparison of Sample Air Voids and Cantabro Loss**

Figure 2 shows the sample air voids and Cantabro loss results for the five OGFC mixtures evaluated during mix design. These two mixture properties were found to be important for the performance of OGFC mixtures in the field. An OGFC mixture with higher air voids is expected to drain water off the pavement surface quicker, and the minimum air void content for OGFC mixtures was estimated to be approximately 15 percent in previous research cycles of the NCAT Test Track. In addition, an OGFC mixture with lower Cantabro stone loss results is anticipated to have better resistance to raveling, and the maximum Cantabro loss for OGFC mixtures compacted to 50 gyrations is 15 percent. A further discussion of the results shown in Figure 2 follows.

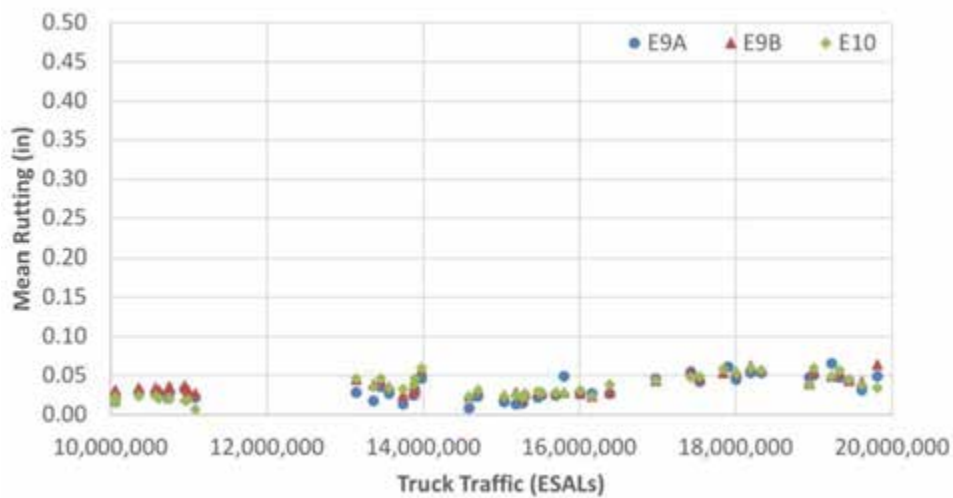
**Figure 4 Rutting Performance Comparison**

All the mixes were placed 0.75 inches thick on the NCAT Test Track, and in-place air voids immediately after construction were approximately 20 percent. After 20 million ESALs were applied in the 2012 and 2015 research cycles, none of the test sections showed cracking. Rutting in all sections was very low at approximately 0.05 inches as shown in Figure 4.

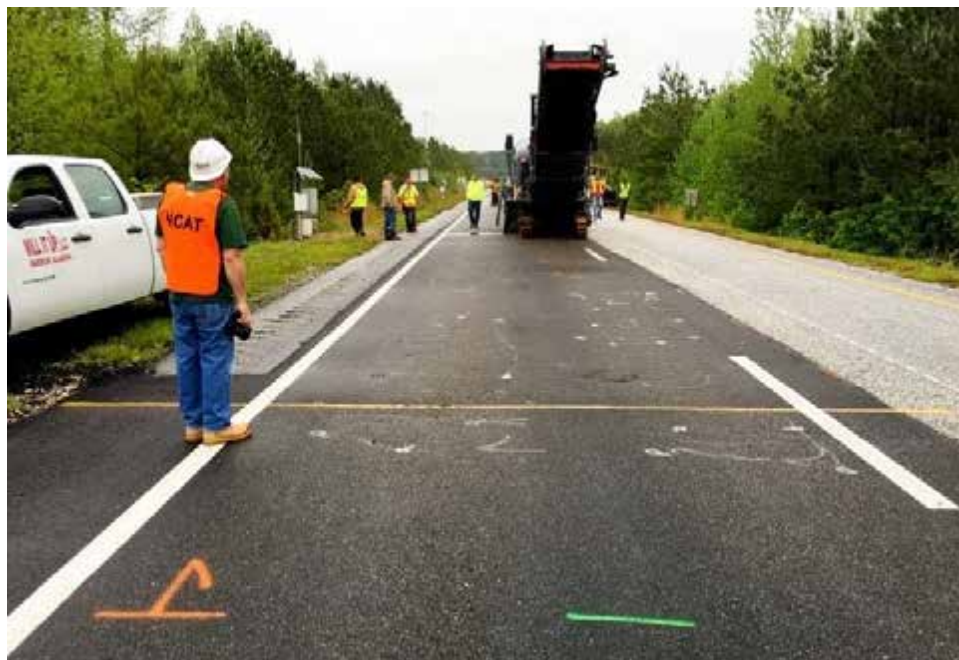
**Figure 1 Milling of the Original Surface of Section N7**

Repaving work started with the removal of the original pavement structure by milling on April 12, 2016, as shown in Figure 1. After compacting the aggregate base and verifying density requirements were met, paving of the base and intermediate asphalt courses started on April 13, 2016 (Figure 2). The surface layer of Section N7 was completed on April 15, 2016.

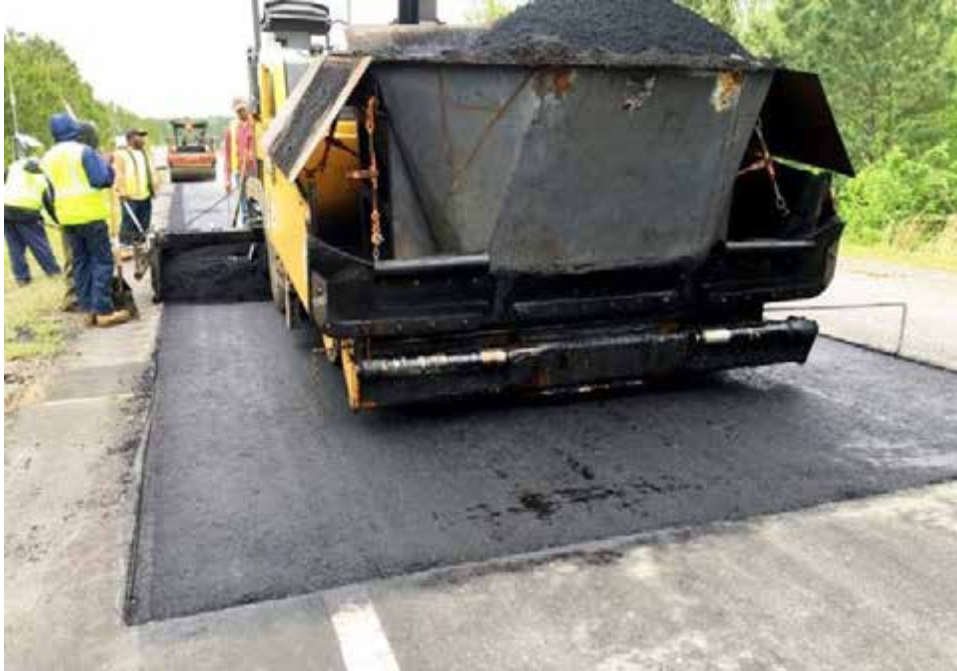
**Figure 2 First Repave of Section N7**

Within one day after the first repave of Section N7 was complete, slippage failures were observed. Figure 3 shows one of the slippage failures seen at this stage. Observation of the asphalt mixture after peeling from its surface with a skid steer revealed an oily and wet interface between the surface and binder layers with an asphalt mixture that was softer than usual and was easily broken, as shown in Figure 4.

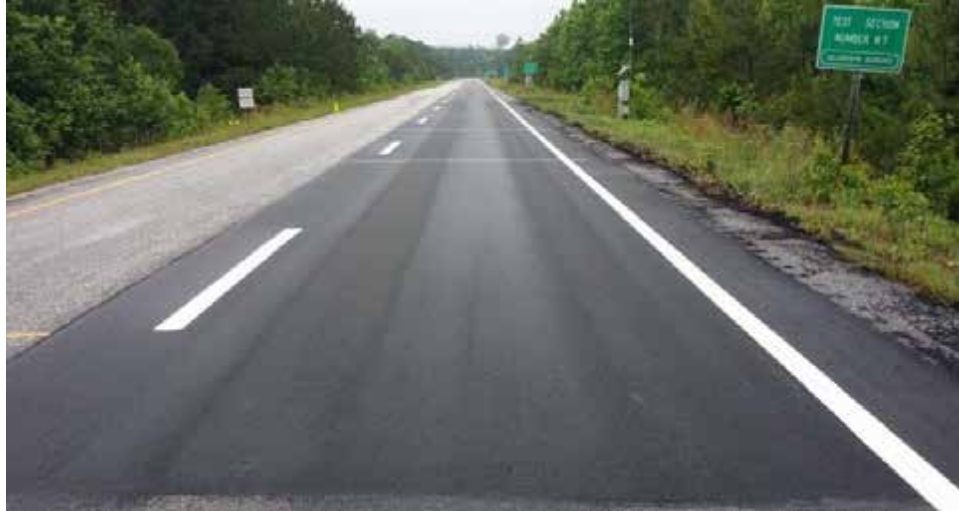
**Figure 7 Section N7 After the Second Repave**

After discussions with the sponsor, it was decided that the interaction between Delta S and the aged binder in the RAS should be further studied and that the wearing course of Section N7 would be replaced with a mixture containing only RAP materials. This mix would have 35% RAP with a recycled binder ratio similar to those of the original N7 and N8 surface mixes. Because this new design did not include RAS (even though it had a similar recycled binder ratio), the Delta S dosage was reduced to 5% by weight of the aged RAP binder, which was 5% lower than the dosage used in the original N7 mix with 20% RAP and 5% RAS. The N7 surface mixture was designed to compare directly with the N1 surface mix, which is the control mix for the Cracking Group experiment. Finally, it was determined that the mixture would be kept in a silo for two hours before paving. The second repave of Section N7 was started the week of May 9th, 2016. By May 12th, work was finished and trafficking was resumed. Figure 7 shows Section N7 after the second repave.

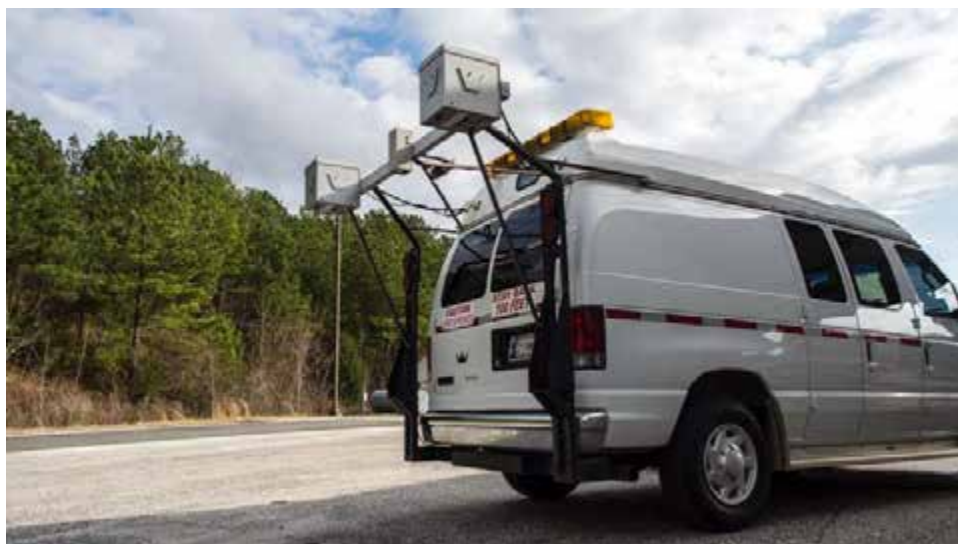
**Figure 9 Inertial Profiler Used to Assess Ride Quality and Rutting Measurement**

The Test Track produces an accelerated accumulation of traffic-produced damage over a reduced time. For each research cycle, 10 million ESALs are applied and pavement responses are constantly monitored. Traffic is suspended each Monday and the pavement sections are measured for ride quality, rutting, and cracking performance. Ride quality and rutting are measured with a Dynatest inertial profiler, shown in Figure 9, which determines the international roughness index (IRI) of each section. For cracking performance, sections are inspected visually, and when observed, cracks are mapped and measured (Figure 10). Cracks are considered to have an area of influence that is 6 inches to each side. Linear measurements of the cracks are performed to determine the cracked area of the sections. With these measurements, cracking is then calculated based on the percent lane area of each section.

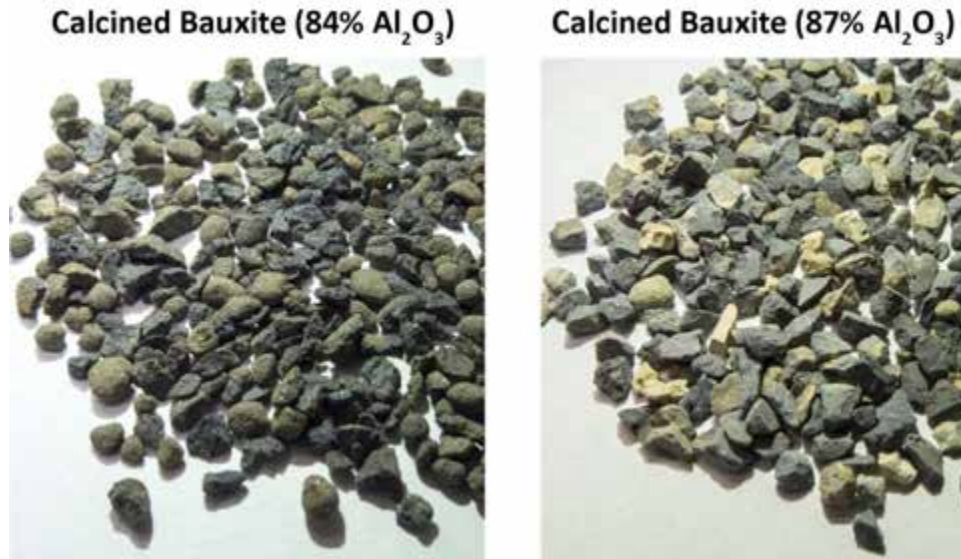
**Figure 1 Calcined Bauxite Samples**

study, so the friction performance was unknown. Great Lakes Minerals maintains a supply of calcined bauxite for HFST meeting AASHTO PP 79-14 (87% minimum  $\text{Al}_2\text{O}_3$ ) but was not able to donate the required quantity. Photos of both samples are shown in Figure 1. The photo of the 84%  $\text{Al}_2\text{O}_3$  calcined bauxite shows both crushed particles and rounded particles, which is atypical of the manufactured calcined bauxite used for HFST shown in the right photo.

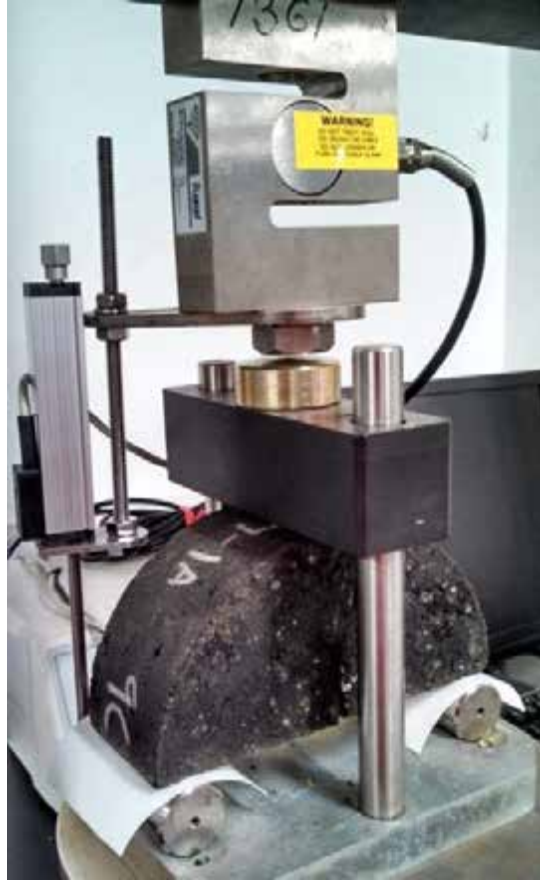
Figure 6 Semi-Circular Bend Test

An MTS<sup>®</sup> servo-hydraulic testing system equipped with an environmental chamber was used to perform the SCB test. As shown in Figure 6, the SCB samples are symmetrically supported by two fixed rollers and have a span of 120 mm. Teflon tape is used to minimize friction between the specimen and the rollers. The plot of load versus external displacement is used to compute the area under the curve to the peak load.

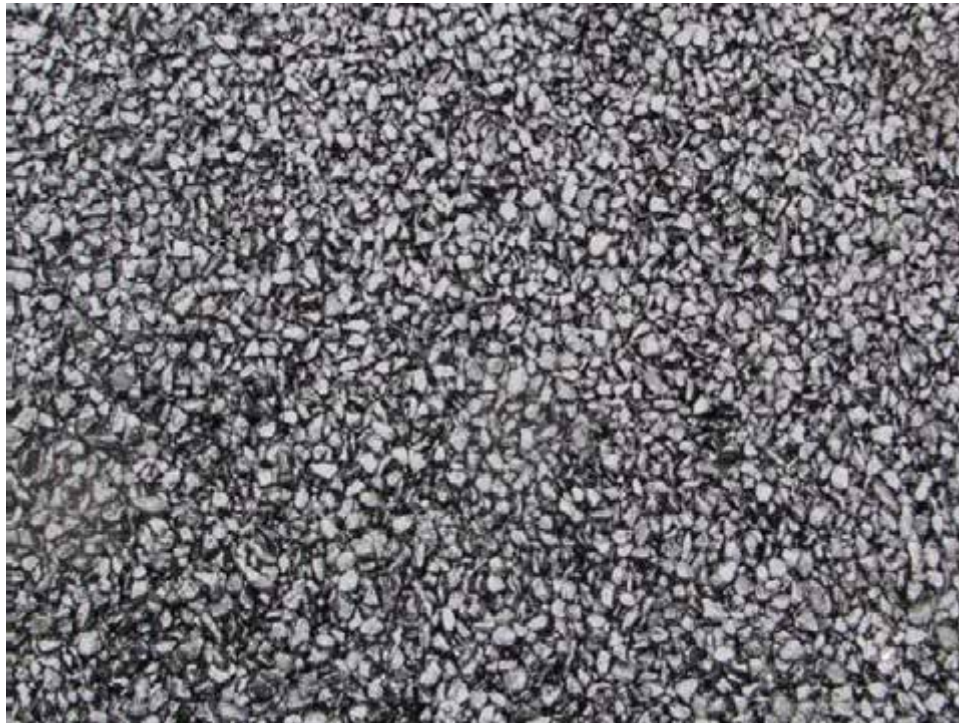
**Figure 3 OGI Interlayer**

The OGI mix, shown in Figure 3, was a 1/2-inch NMAS porous friction course (PFC) mixture that was designed with a lower asphalt content than a typical PFC surface mix and used PG 64-22 binder grade. It also omitted fiber stabilizer for economic reasons, and instead used a reduced mix temperature of 250°F ± 20°F to resist drain-down. The purpose of this mix was to provide a discontinuity between the existing surface and overlay (to relieve stresses from loading and thermal forces) so stresses are dissipated and cracks are not as easily reflected.

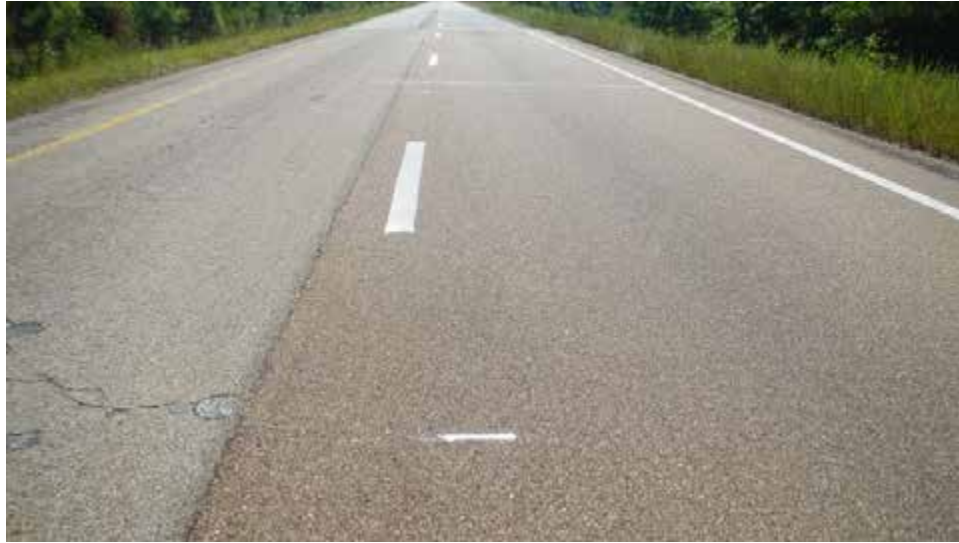
**Figure 2 Crack Observed in Section S3 Near the Inside Edge of the Outside (Research) Lane**

Weekly monitoring of each test section was conducted on Mondays. Each section was inspected for signs of cracking and multiple measurements of rutting and surface roughness were made. Similar to the 2003 MDOT thinlay, this mix has now supported over 20 million ESALs with no cracking, rutting, roughness, raveling, or friction deficiencies noted. At the end of the 2015 cycle, the final rut depth measured was 0.05 inches, and the amount of cracking observed was 0.2% based on the total lane area. Figures 2 and 3 show two low-severity cracks observed in Section S3.

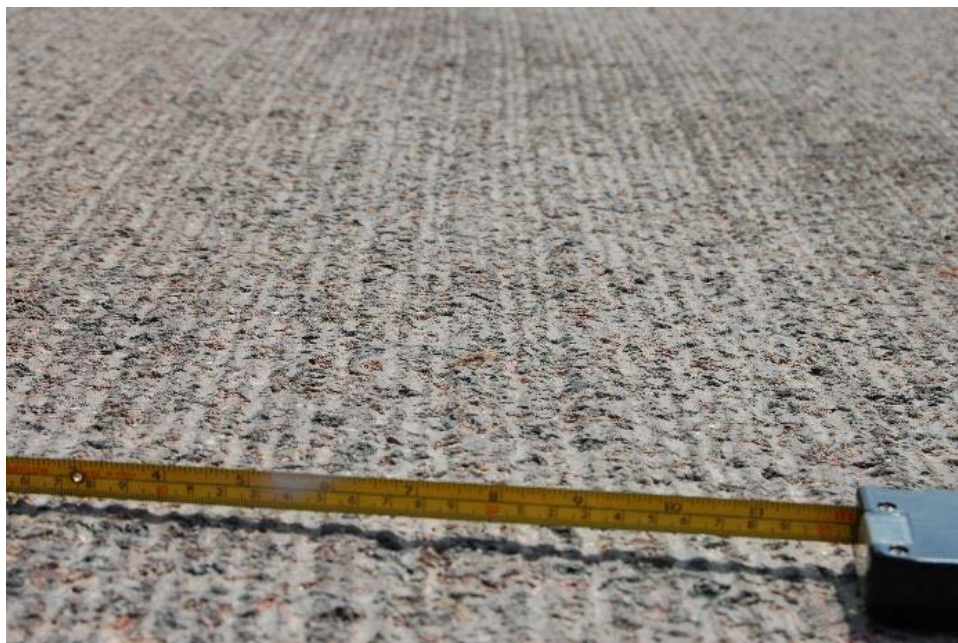
**Figure 1 Finished Micro-Milled Surface of Section N9**

On August 14, 2015 the micro-milled surface (Figure 1) of Section N9 was tacked with UltraFuse at an application rate of 0.05 gal/yd<sup>2</sup> residual for the first 100 ft and 0.10 gal/yd<sup>2</sup> residual for the second 100 ft (Figure 2). The 0.10 gal/yd<sup>2</sup> rate for the second 100 ft was accomplished by repeating the 0.05 gal/yd<sup>2</sup> rate over the 0.05 gal/yd<sup>2</sup> rate initially applied to the entire 200 ft section. The left longitudinal joint was tacked with an overlap of at least 2 in. to maximize longitudinal joint performance (Figure 3). An area approximately one foot wide on the right edge was not tacked because the width of the distributor spray bar was extended to accommodate the left longitudinal joint overlap. The omission of tack on the right edge of the lane is not expected to impact the study. The sandstone OGFC was placed 0.75-in. thick on the tacked surface (Figure 4).

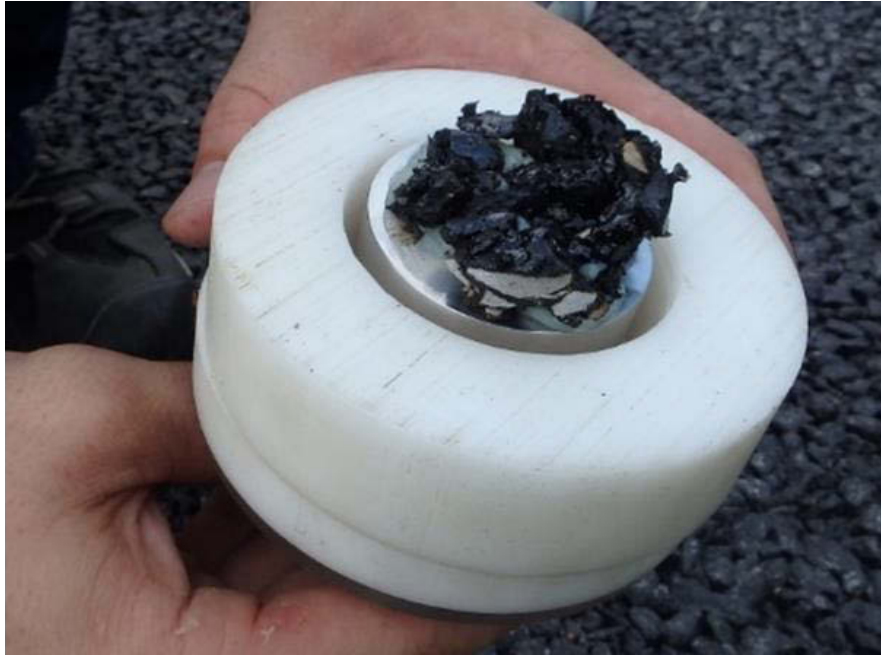
**Figure 10 Photo and Table Record of First Test Day**

Test Date	8/21/2015	Age=7 days	Pavement Surface Temp = 132° F	
Test #	Section	Load (kN)	Comments	
1	N9A	0	Broke in OGFC without registering load	
2	N9A	0	Broke in OGFC without registering load	
3	N9A	0	Broke in OGFC without registering load	
4	N9A	0	Broke in OGFC without registering load	
5	N9A	0	Broke in OGFC without registering load	
6	N9A	0	Broke in OGFC without registering load	
7	N9B	0	Broke in OGFC without registering load	
8	N9B	0	Broke in OGFC without registering load	
9	N9B	0	Broke in OGFC without registering load	
10	N9B	0	Broke in OGFC without registering load	
11	N9B	0	Broke in OGFC without registering load	
12	N9B	0	Broke in OGFC without registering load

NOTE: The OGFC temperature was too high and no load was registered by the testing device because the OGFC layer was stretching and tearing.

As testing proceeded, two parameters of the test were modified. One, the pavement surface must be a low, early morning temperature, and two, the rate of tensile pull was increased. A summary of each day of testing follows in Figures 10 through 13.

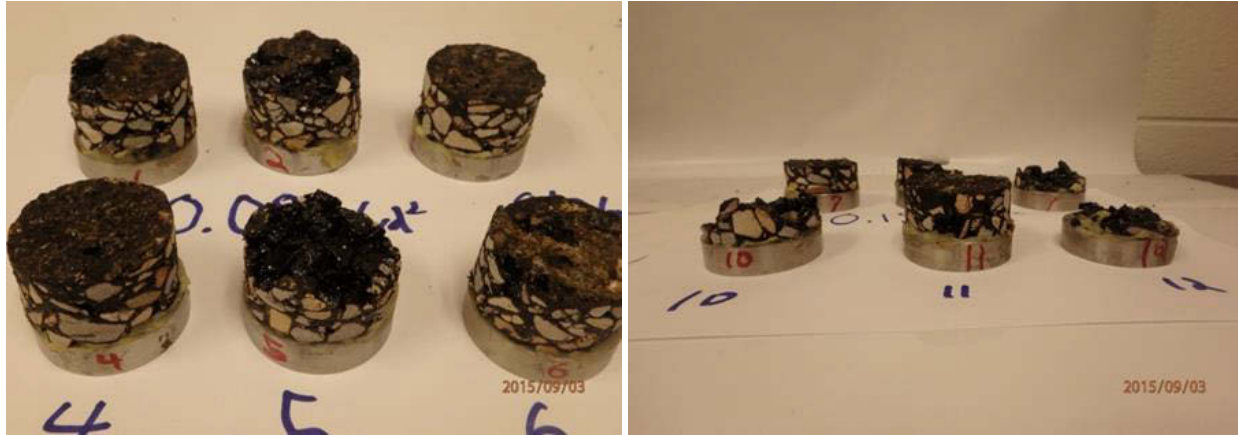
**Figure 11 Photos and Table Record of Second Test Day**

Test Date	8/28/2015	Age=14 days	Pavement Surface Temp = 80°F
Test #	Section	Load (kN)	Comments
1	N9A	0.2	Broke at tack interface
2	N9A	0.3	Broke at tack interface
3	N9A	0.2	Broke at tack interface
4	N9A	0.2	Broke at tack interface
5	N9A	0.2	Broke in OGFC
6	N9A	0.2	Broke at tack interface
7	N9B	0.3	Broke at tack interface
8	N9B	0.4	Broke in OGFC
9	N9B	0.3	Broke in OGFC
10	N9B	0.3	Broke in OGFC
11	N9B	0.2	Broke at tack interface
12	N9B	0.2	Broke in OGFC

NOTE: Cooler temperatures led to measurable loads on the testing device, but the values are very small considering the maximum load of the device (100 kN). There is a visual difference between tests ran on N9A and N9B. A majority of N9A broke at the tack interface. N9B had a higher tack rate, and the majority of the tests broke in the OGFC above the interface.

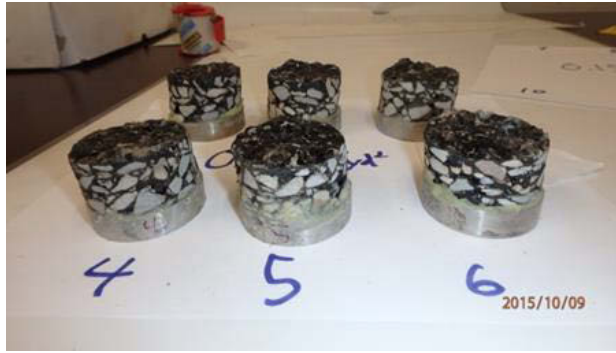
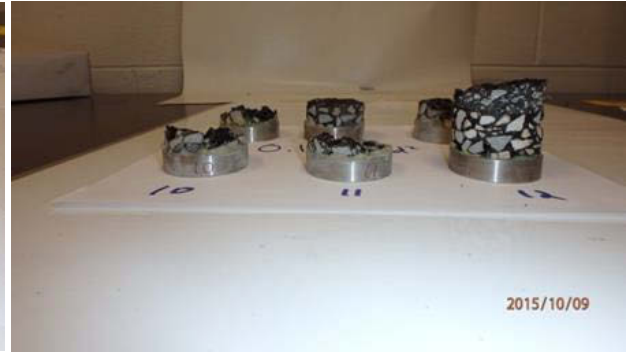
Test Date	9/17/2015	Age=34 days	Pavement Surface Temp = 65°F
Test #	Section	Load (kN)	Comments
1	N9A	0.7	Broke at tack interface
2	N9A	0.7	Broke at tack interface
3	N9A	0.8	Broke at tack interface
4	N9A	0.6	Broke at tack interface
5	N9A	0.9	Broke at tack interface
6	N9A	0.8	Broke at tack interface
7	N9B	1.2	Broke in OGFC
8	N9B	1.0	Broke at tack interface
9	N9B	1.0	Broke in OGFC
10	N9B	0.9	Broke in OGFC
11	N9B	1.0	Broke in OGFC
12	N9B	0	Broke in dense-mix

NOTE: Similar results to previous testing date. Lower pavement temperatures recorder higher peak loads. There was a visual difference between N9A and N9B specimens.

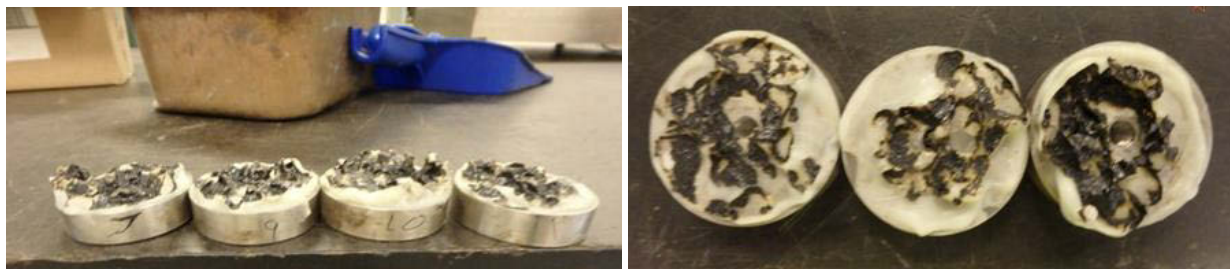
**Figure 12 Photos and Table Record of Third Test Day**

Test #	Section	Load (kN)	Comments
Test Date 10/19/2015      Age=66 days      Pavement Surface Temperature = 60°F			
1	N9A	0.1	Broke at epoxy/OGFC
2	N9A	0.1	Broke at epoxy/OGFC
3	N9A	0.6	Broke at epoxy/OGFC
4	N9A	0.3	Broke at epoxy/OGFC
5	N9A	0.9	Broke at epoxy/OGFC
6	N9A	0	Broke during coring
7	N9B	1.6	Broke at epoxy/OGFC
8	N9B	0.6	Broke at tack interface
9	N9B	0	Broke at epoxy/OGFC
10	N9B	1.0	Broke at epoxy/OGFC
11	N9B	0.6	Broke at epoxy/OGFC
12	N9B	0.9	Broke at tack interface

FIELD NOTE: Had trouble with specimens breaking at epoxy/OGFC interface. There appears to be less bond area for epoxy. Coring, gluing, and testing were all done before sunrise, so epoxy may not have had ample time to harden before testing or the pavement surface was not dry.

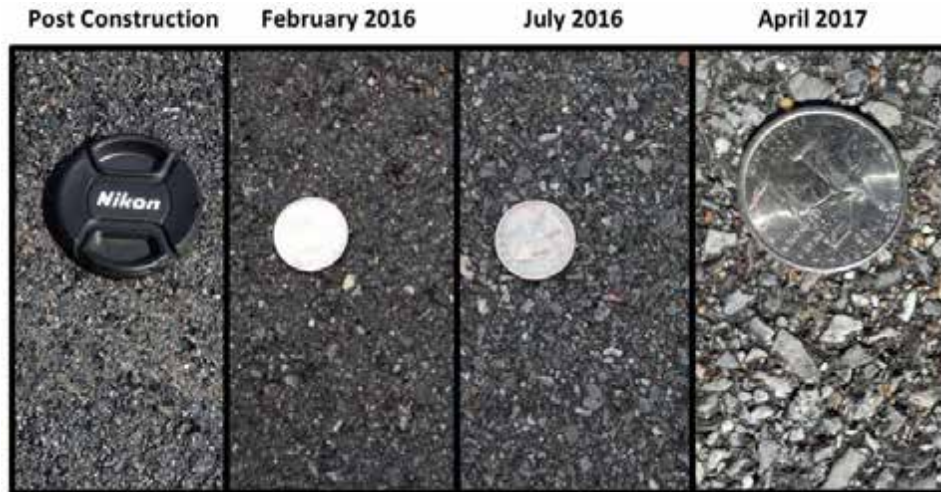
**Figure 8 Change in Surface Appearance**

Pre-traffic noise measurement using the on-board sound intensity (OBSI) system was 94 dB(A). As the mastic was removed and exposed more surface texture, the OBSI noise increased to 97 dB(A) on the average, ranging from 95 to 98 dB(A). The OBSI 3<sup>rd</sup> octave data was relatively flat, starting at 69 dB(A) for 315 Hz frequency, increasing to 89 dB(A) for 800 Hz, and dropping to 72 dB(A) for 4000 Hz prior to traffic. During the two-year trafficking cycle, the 3<sup>rd</sup> octave data measured as high as 76 dB(A) for 315 Hz, increasing to 93 dB(A) for 800 Hz, and dropping to 76 dB(A) for 4000 Hz. The impedance tube sound absorption measurements agreed with the OBSI values. Generally, 3% absorption was measured at 315 and 400 Hz, no absorption was measured at 630 and 800 Hz, and 13% absorption was measured at 1600 Hz. These noise characteristics are reasonable for a dense-graded small nominal maximum aggregate size thin lift.
