NCAT Draft Report 24-01

May 2024

Phase VIII (2021-2024) NCAT Test Track Findings

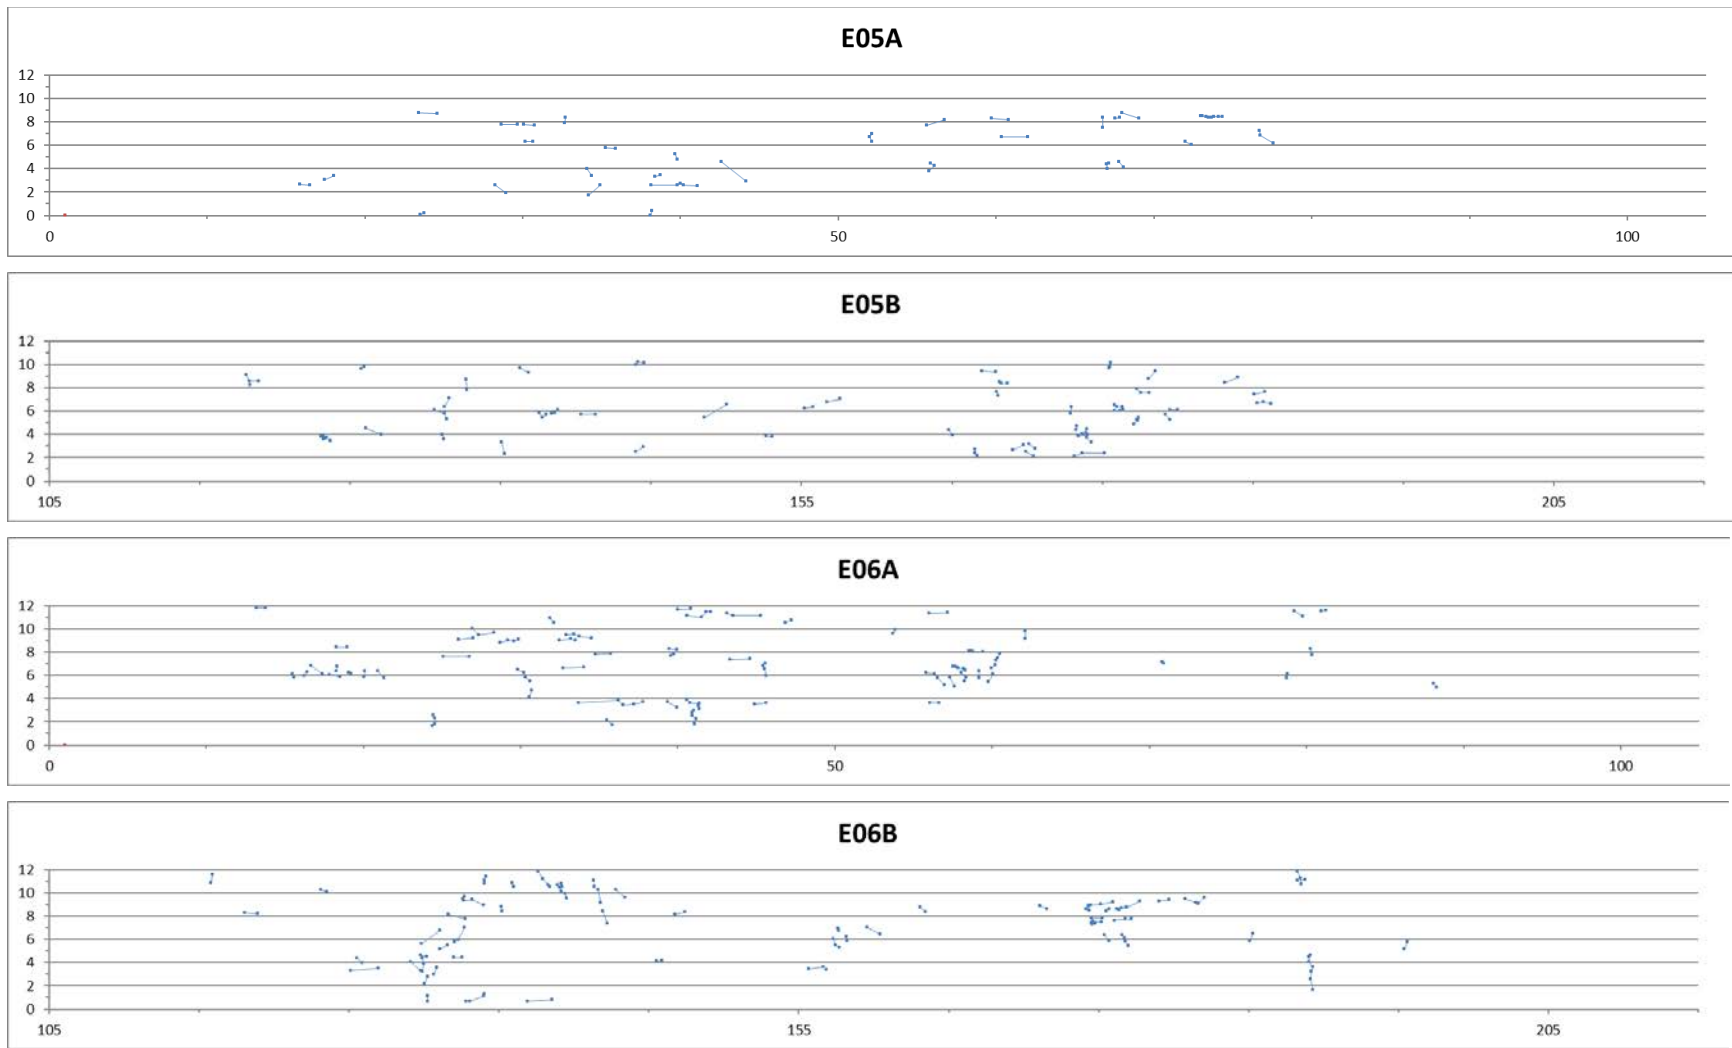
FIGURE 8 Crack maps for the Florida DOT in-place density subsections at 20 million ESALs.

Crack maps of the four subsections are shown in Figure 8. As can be seen from these maps, the cracks in E5A (93.6% of G_{mm}) and E5B (92.0% of G_{mm}) are more dispersed throughout the section, whereas the cracking in E6A (87.0% of G_{mm}) and E6B (89.7% of G_{mm}) is more clustered. The reason for the clustering of cracks is unknown.

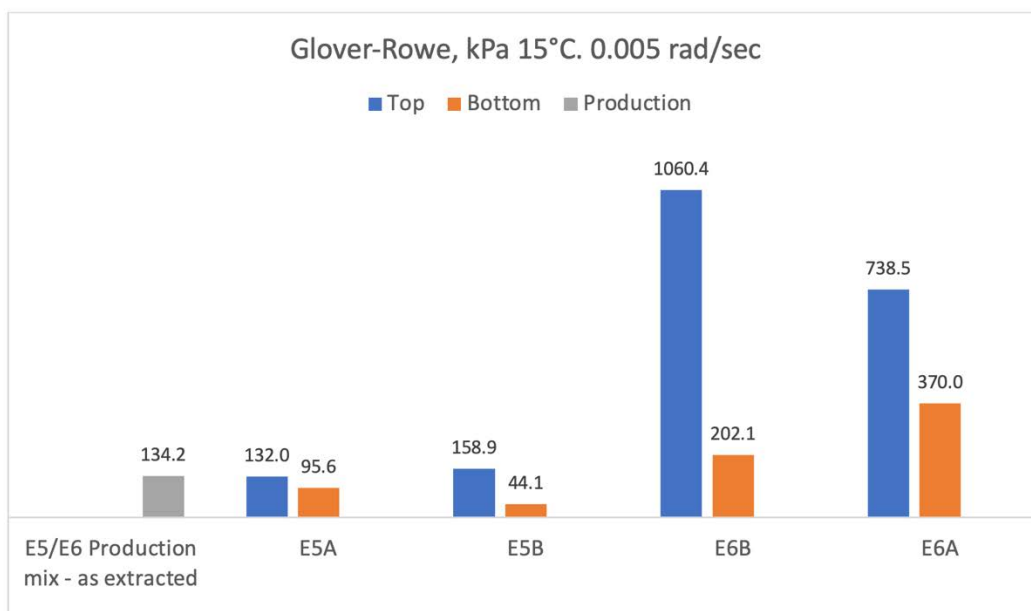
FIGURE 22 Glover-Rowe parameter of the recovered binders from the density experiment subsections.

Figure 22 shows the GR results for the recovered binders from the tops and bottoms of the subsections and the production mix. Once again, the results followed a similar trend to the criteria discussed previously. The recovered binders from the tops and bottoms of the lower in-place density subsections had significantly higher GR values than the recovered binders from the higher in-place density subsections and the production mix. This indicates increased aging throughout the thickness of these subsections. The recovered binders from the tops and bottoms of the higher in-place density subsections had GR values that were comparable to or slightly better than the production mix, indicating less aging for these subsections.

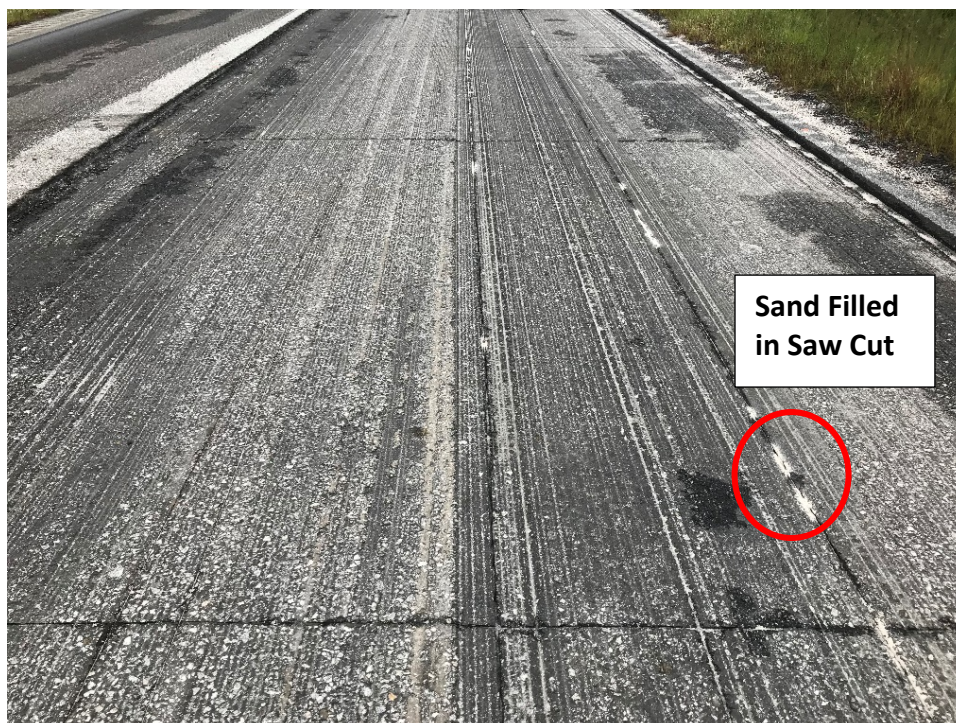
FIGURE 1 Deep saw cuts to simulate pavement cracks.

As depicted in Figure 1, these cuts were longitudinally aligned at intervals of 3 feet (0.91 meters) across the lane width and 15 feet (4.57 meters) in the transverse direction. The area impacted by the saw cuts accounted for roughly one-third of the test section's total surface area, assuming an influence zone of 1 foot (0.30 meters) on each side of the crack. The cuts were subsequently filled with sand to prevent the cracks from resealing during construction and warm weather conditions. The saw-cut pattern for this cycle replicated that of the previous research cycle.

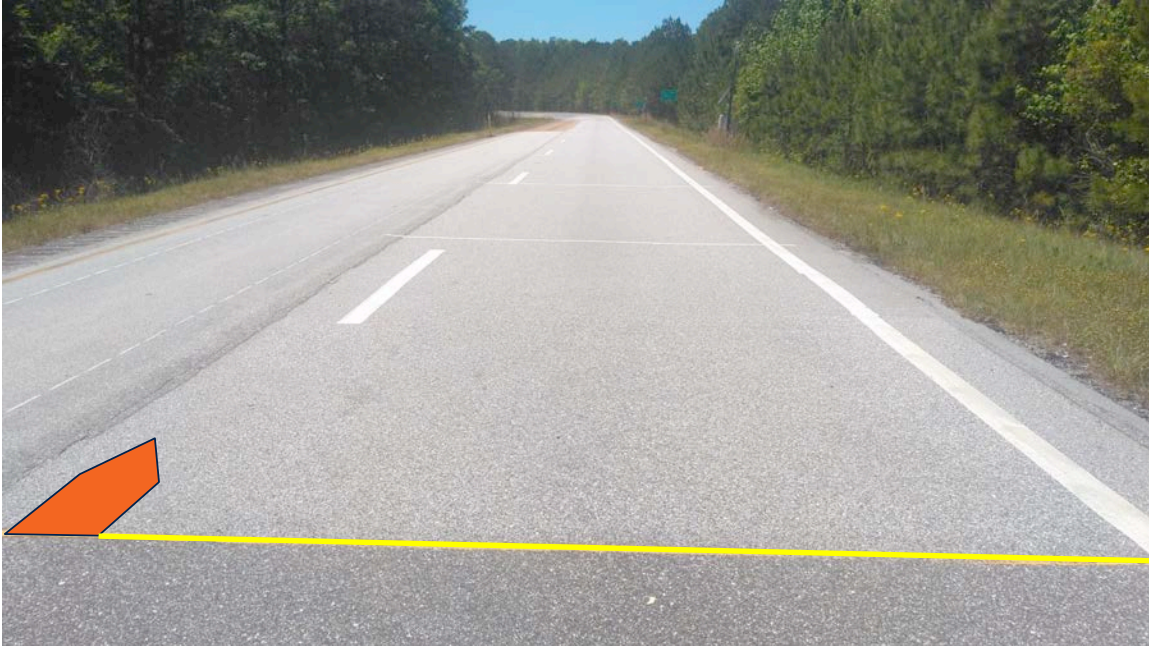
FIGURE 13 Subsection N12-A GlasGrid[®], 0.24-inch rutting, no cracking (April 2024).

The final surface after loading for each section is shown in Figures 13 through 18. The yellow superimposed line marks the start of each subsection.

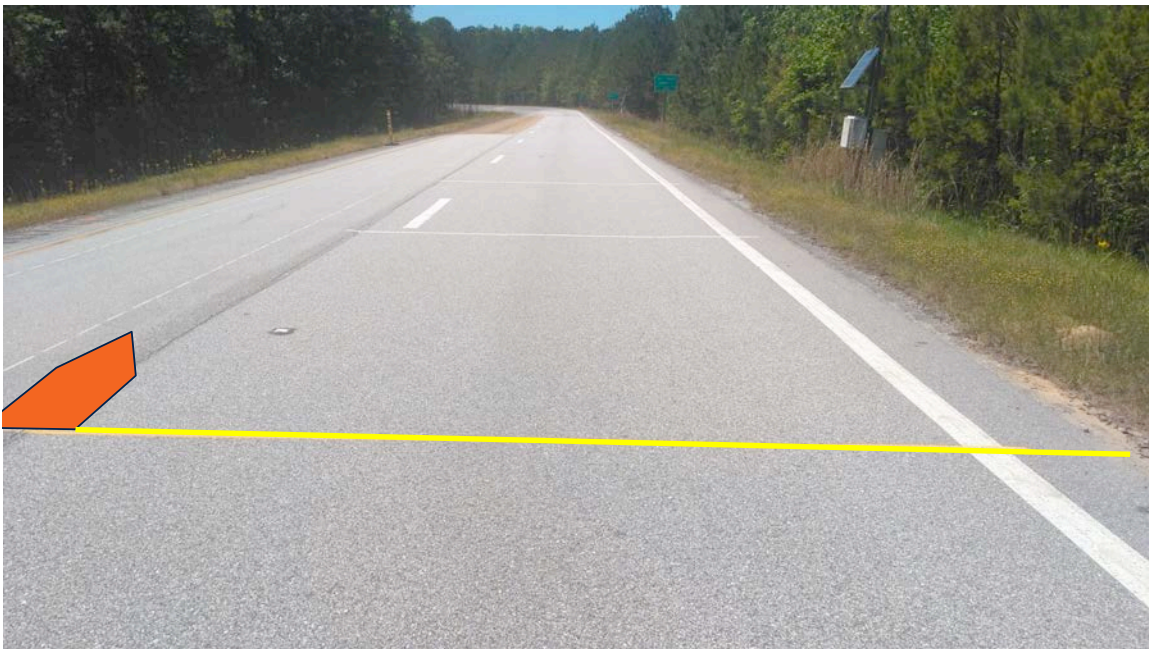
FIGURE 14 Subsection N12-B PETROMAT[®], 0.27-inch rutting, no cracking (April 2024).

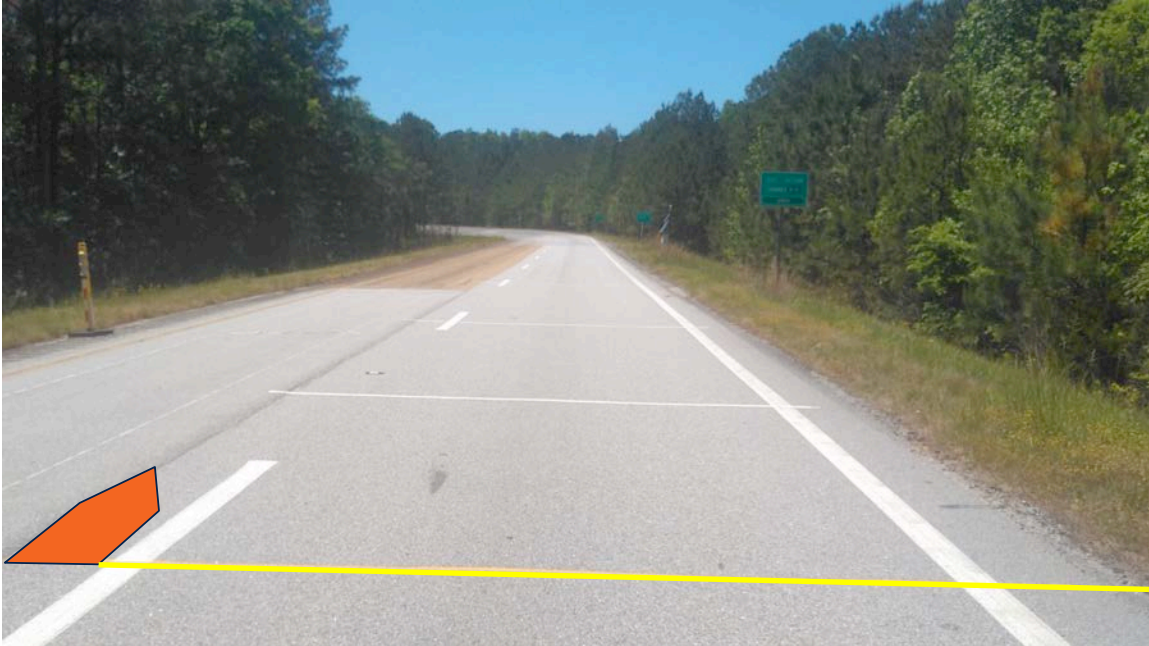
FIGURE 15 Subsection N12-C virgin chip seal, 0.21-inch rutting, no cracking (April 2024).

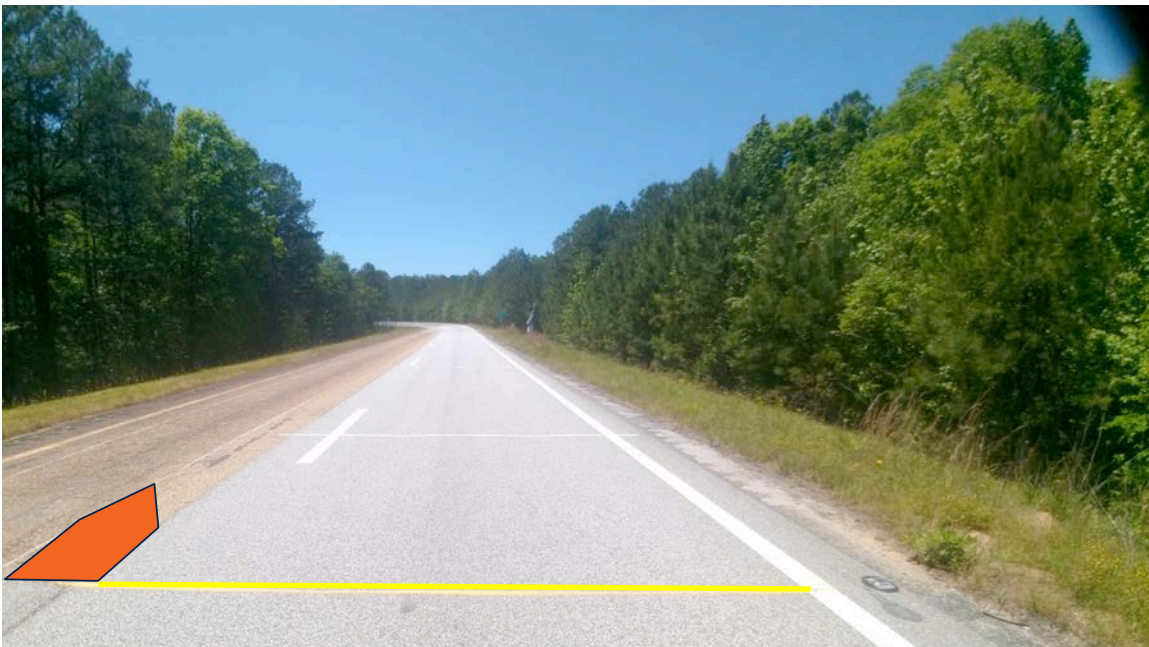
FIGURE 16 Subsection N13-A RAP chip seal, 0.41-inch rutting, 0.8% cracking (April 2024).

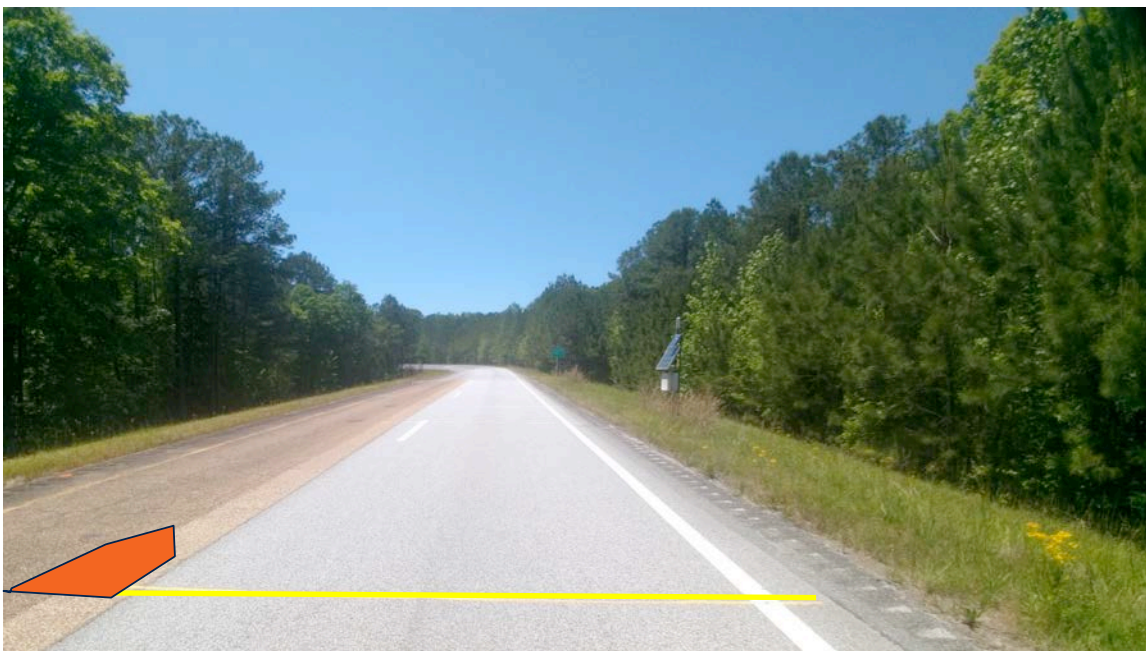
FIGURE 17 Subsection N13-B ARGG, 0.35-inch rutting, 3.1% cracking (April 2024).

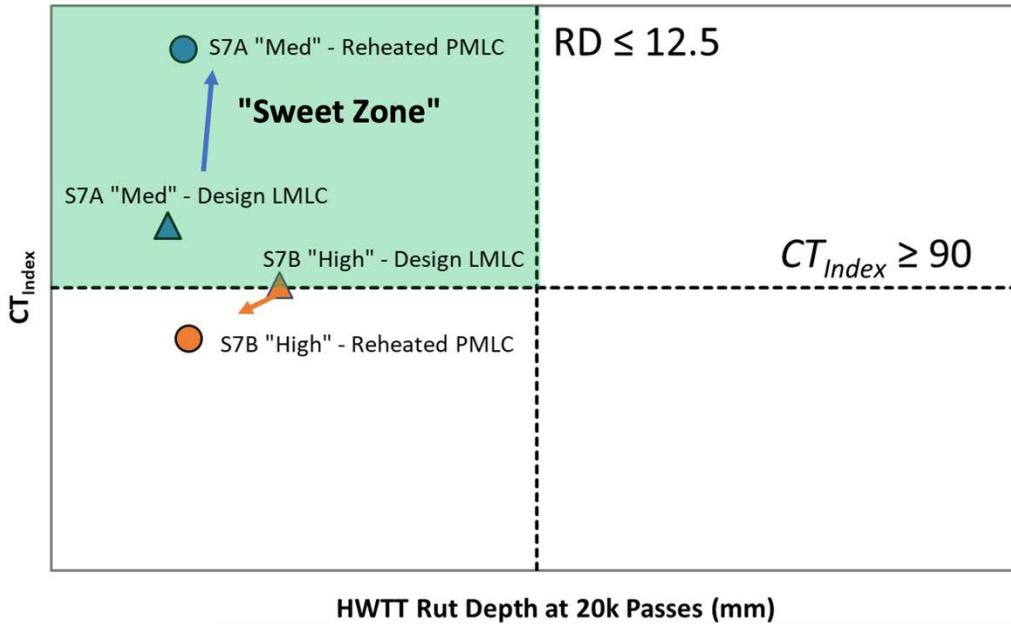
FIGURE 9 BMD performance diagram from S7A and S7B reheated mix testing.

A production sample was taken from each mix during construction and transported to the NCAT laboratory for future testing. The mix was later reheated in metal buckets to the compaction temperature to produce plant-mixed, lab-compacted (PMLC) performance testing results to compare to the lab-mixed, lab-compacted (LMLC) results from mix design. HWTT and IDEAL-CT were conducted to evaluate rutting and cracking resistance, respectively, of the mixes in Sections S7A and S7B. Figure 9 shows the results of these tests plotted in the same performance space diagram as in Figure 4. Arrows indicate the changes from design to reheated PMLC results. The reheated S7A PMLC mix remained in the “sweet zone,” passing both HWTT and IDEAL-CT criteria. The S7B reheated PMLC mix dipped below the CT_{Index} threshold to 74 but remained well below the HWTT threshold. Field evaluation was necessary to determine the quality of the S7B mix and the validity of the IDEAL-CT threshold of 90 as a performance threshold for the KYTC mixes.

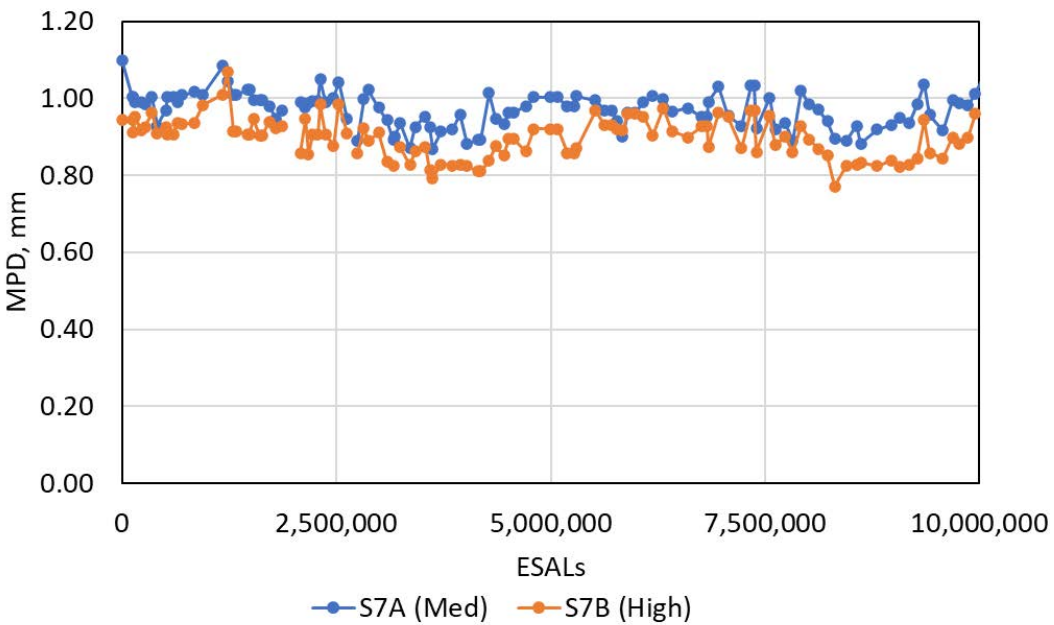
FIGURE 12 MPD performance of S7A and S7B.

Figure 12 shows the Mean Profile Depth (MPD) of the sections. Section S7A was 8% coarser on the #4 sieve compared to Section S7B, as previously shown in Table 3. The coarser gradation of S7A compared to S7B is likely the reason for the increased macrotexture. The texture of both sections slightly decreased over time, likely due to densification of the surface mixes and lack of raveling due to sufficient asphalt contents. The texture of both sections is as expected when compared to previous Test Track sections with similar gradations (Moore, 2023).

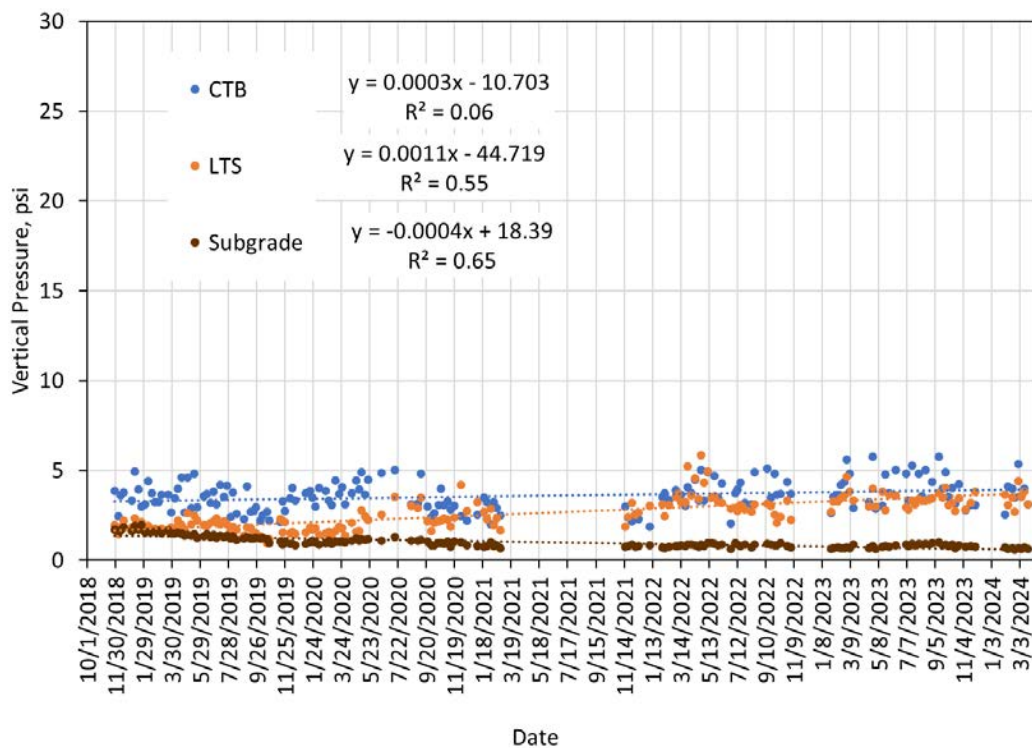
FIGURE 7 Vertical pressure in Section S2 at 68°F versus date.

As detailed in Figure 1, three earth pressure cells were installed to measure the vertical pressure at the top of the cement treated base (CTB), at the top of the lime treated soil (LTS), and at the top of the Mississippi subgrade (Subgrade), respectively. Figure 7 shows the temperature-normalized pressure measurements from both test cycles versus the measurement date, following the process described by McCarty (2019). The gap in the middle of each data set represents the break between test cycles.

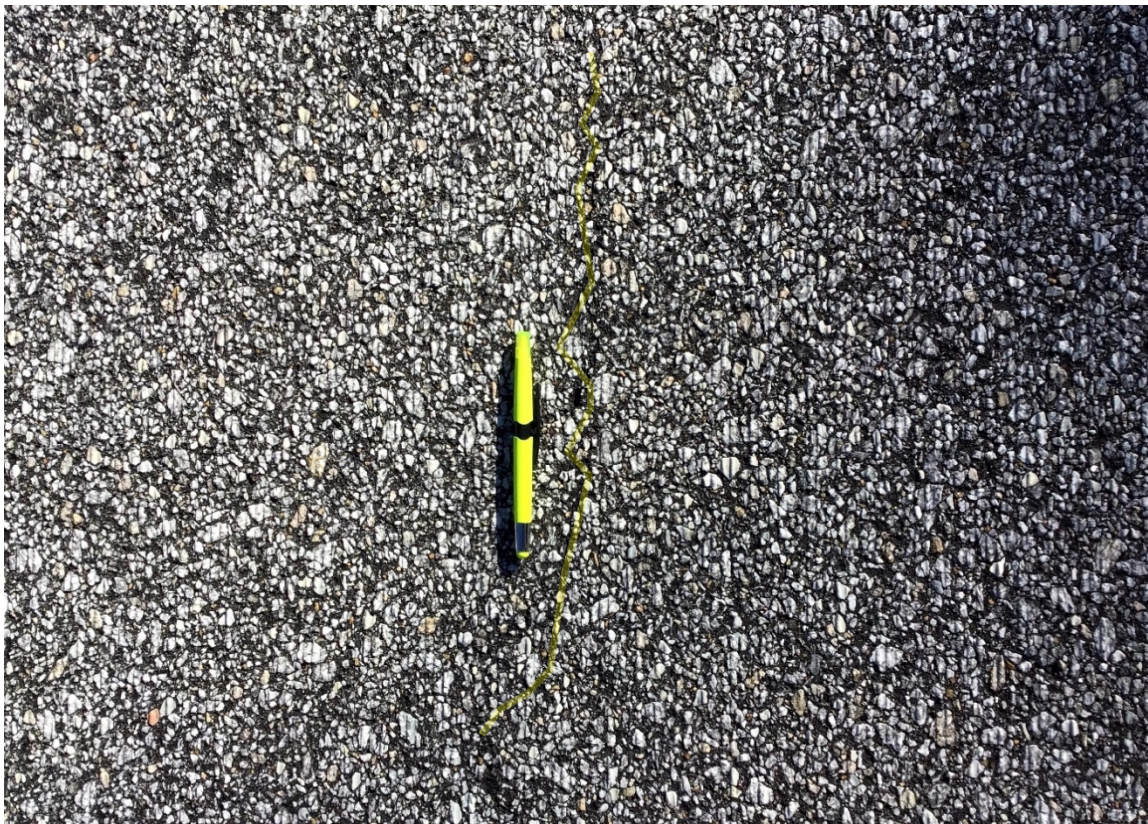
FIGURE 4 Longitudinal crack at edge of inside wheelpath in S9 at end of first test cycle.

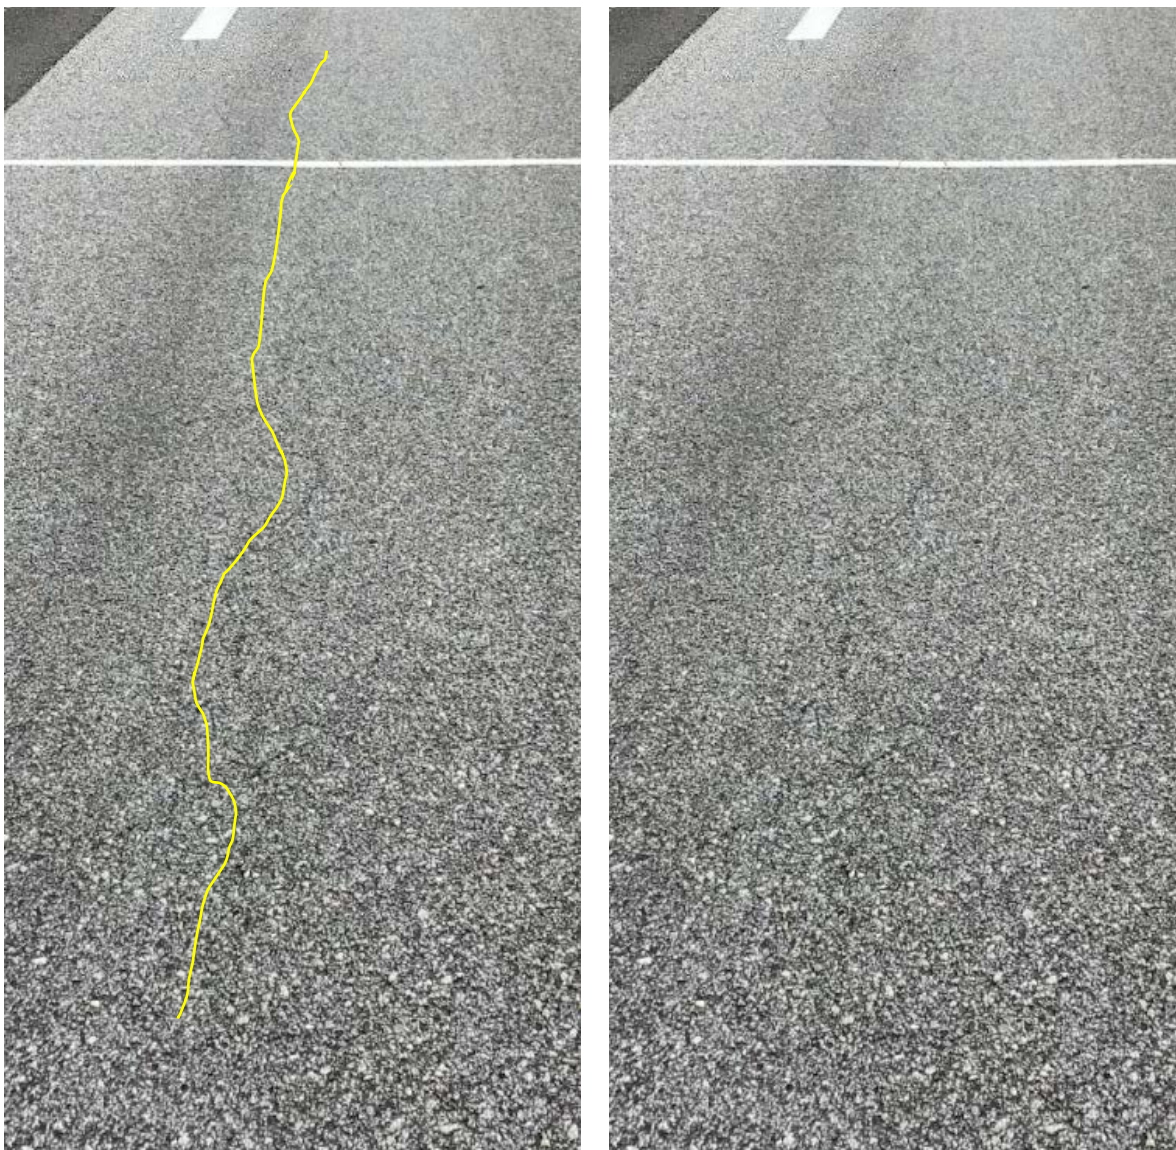
FIGURE 6 Longitudinal crack at edge of inside wheelpath in S9 at end of second test cycle (with and without highlighting).

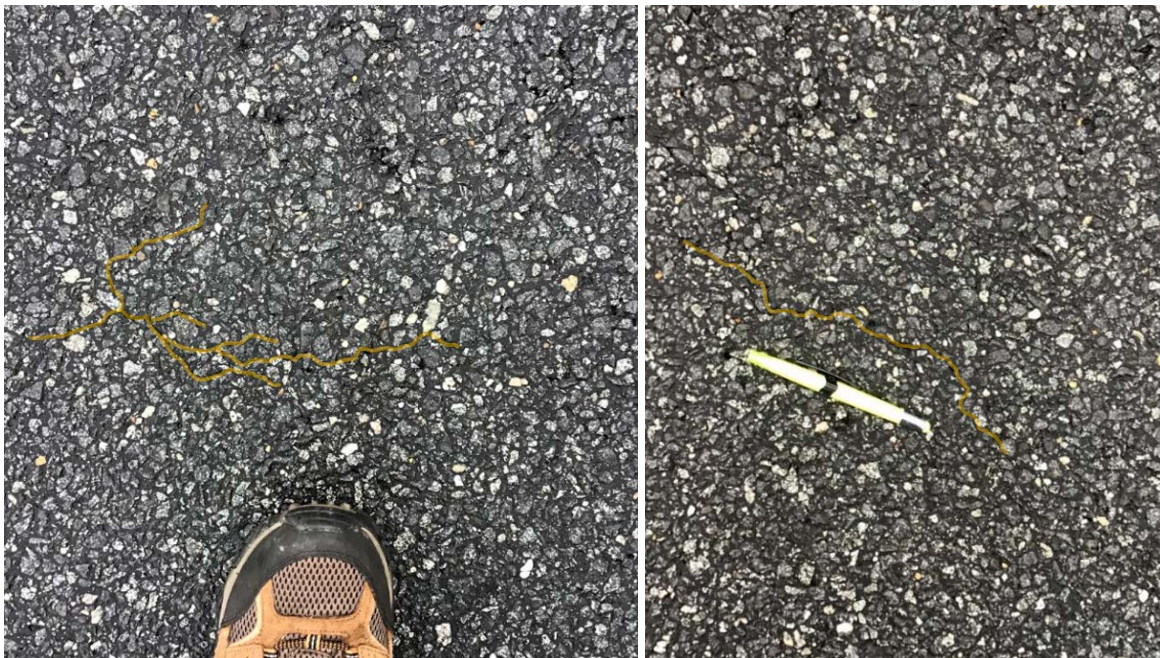
FIGURE 2 Sample cracking in N4 on 1/25/2021 (29.6 million ESALs).

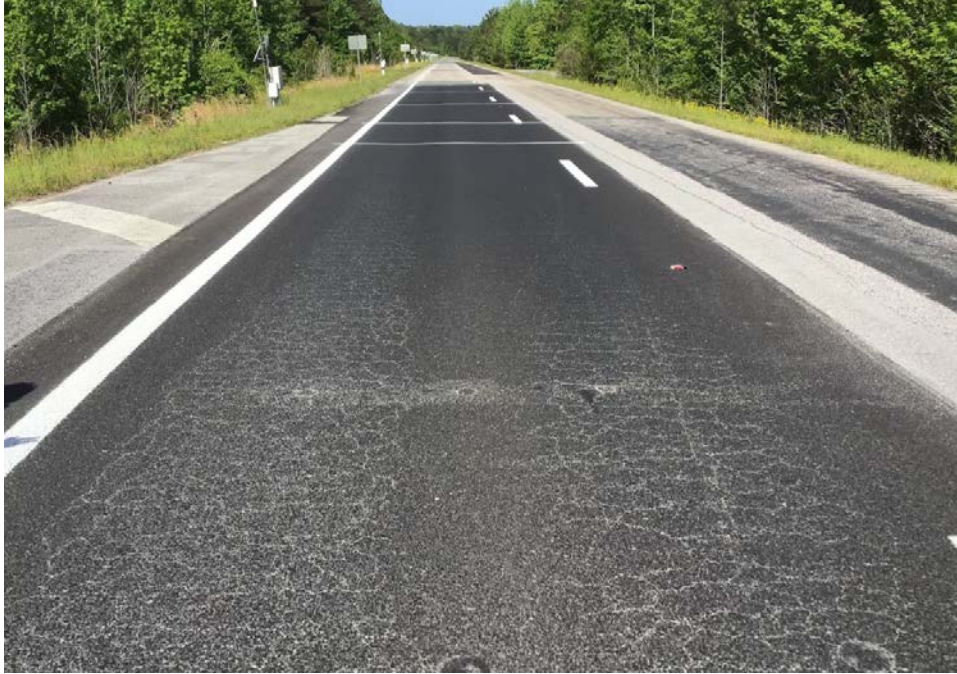
FIGURE 5 Cracking in Section S12 at approximately 1.3 million ESALs (April 2022).

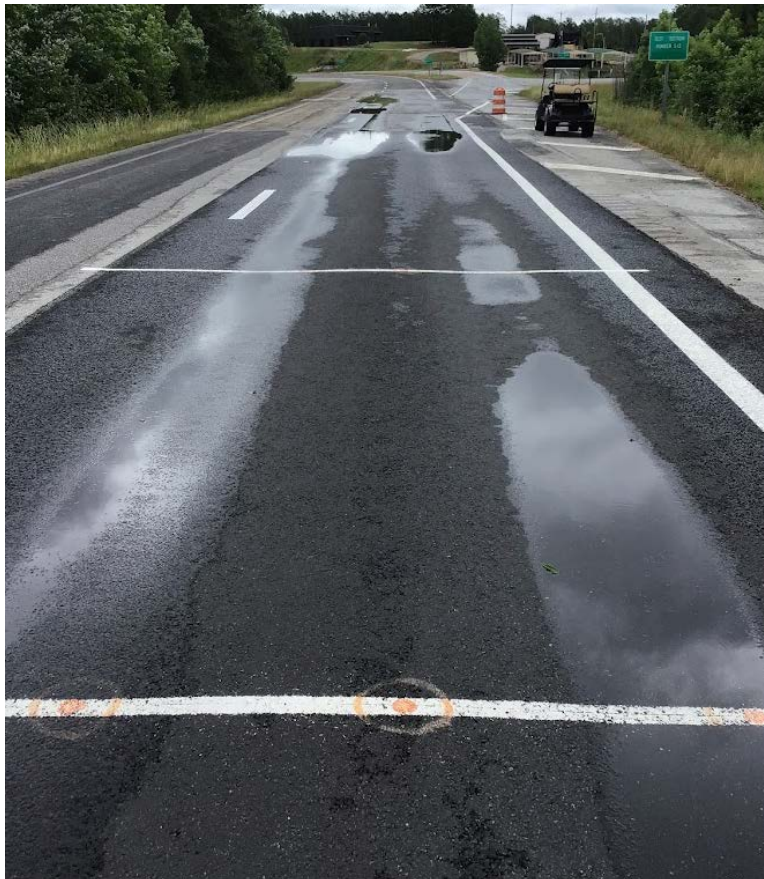
FIGURE 6 Rutting in Section S12 (April 2022).

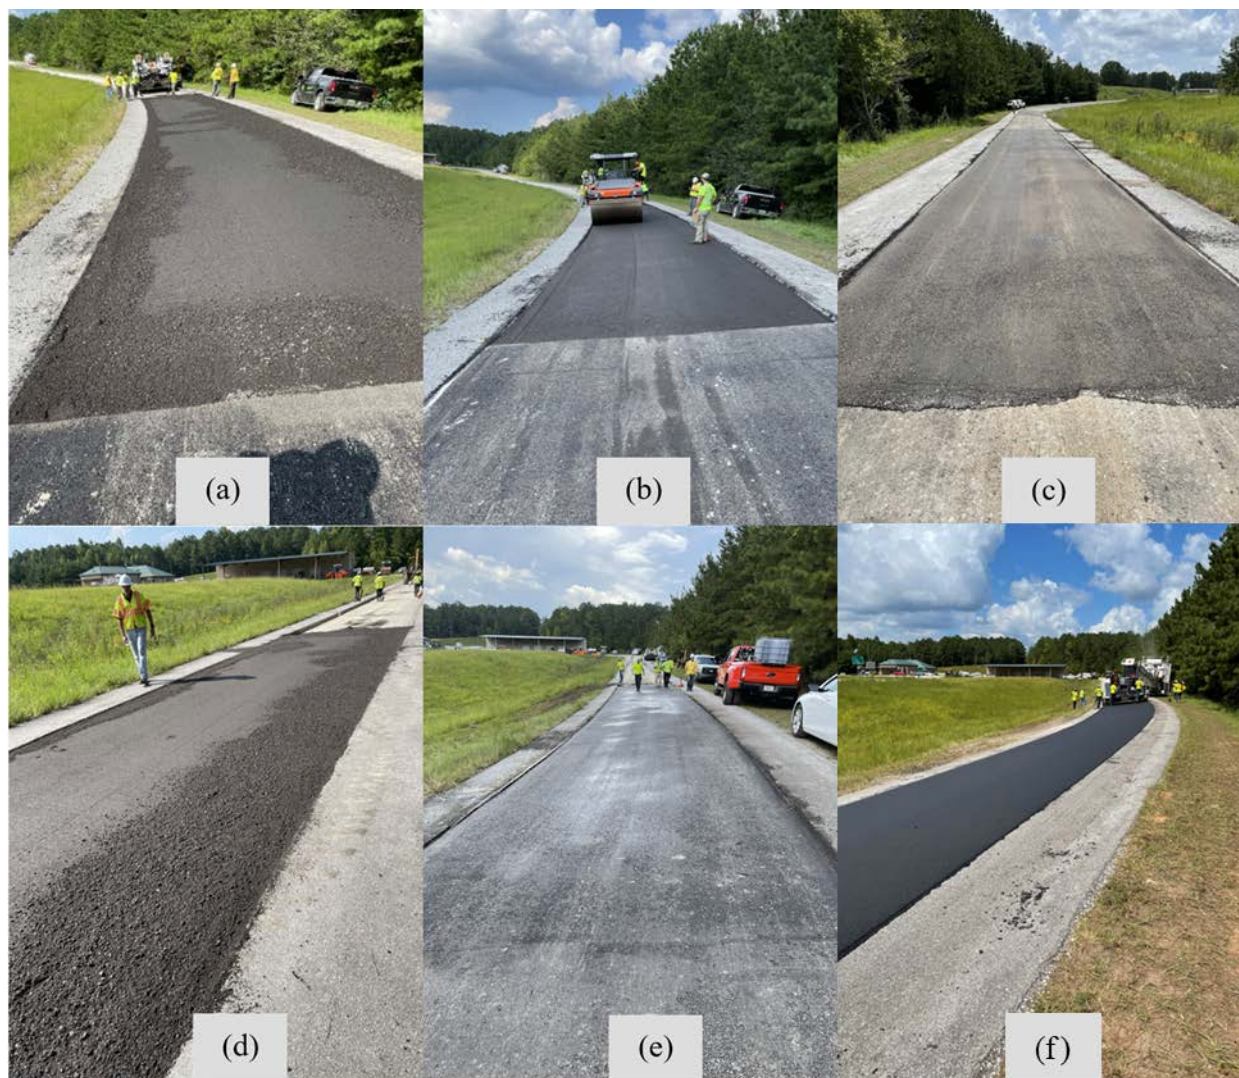
FIGURE 4 Paved CCPR Sections on off-ramp; (a) foamed asphalt with active filler, (b) engineered emulsion, (c) CR rejuvenator, (d) emulsified bio-based rejuvenator; (e) emulsified bio-based rejuvenator, and (f) HMA thinlay overlay.
